DOCUMENT FORM BORESCOPE INSPECTION FORM

Engine Borescope Inspection

Job No: WO/089-SNK/X/2022

<u>Engine Serial Number</u> PCE-PC2316	<u>Date</u> 16-OCT-22	<u>Base / Location</u> TRK	<u>Aircraft Registration</u> PK-SNM
<u>Aircraft Total Time</u> 3865:18	<u>Aircraft Total Cycle</u> 5341	<u>Reason For Borescope</u> ON CONDITION

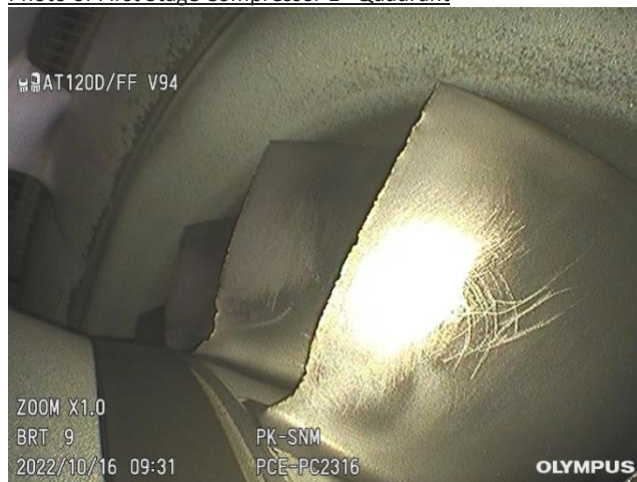
Photo of First Stage Compressor 1st Quadrant

Item	Work Description	Sign	STAMP
1	Remove fuel manifold adapter as necessary (Ref. 73-10-05).		
2	Perform inspection of the First Stage Compressor. <u>Defects:</u> RESULT GOOD NEED COMPRESSOR WASHING <u>If defects found, quote MM Limitation and References :</u>

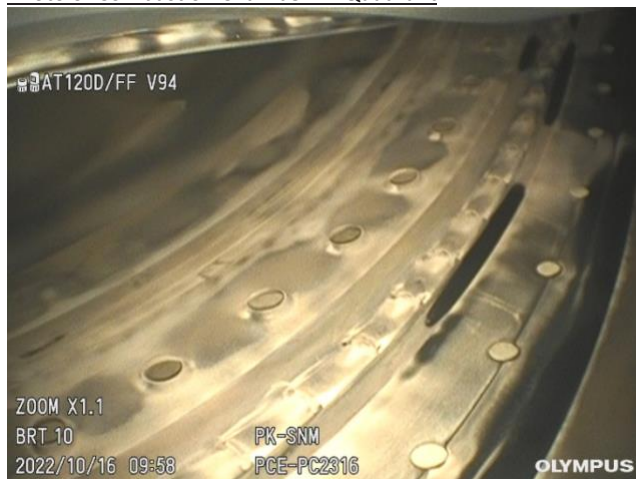
Photo of Combustion Chamber 1st Quadrant

RESULT SATISFACTORY FOUND NO DEFECT NEEDED DESALINATION WASH

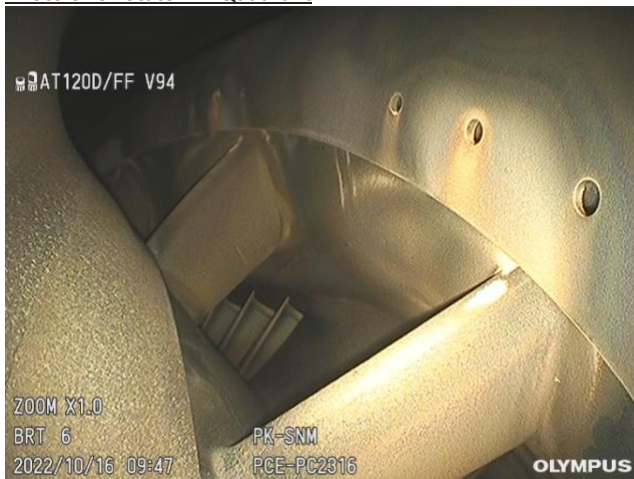
Photo of CT Stator 1st Quadrant

RESULT SATISFACTORY FOUND NO DEFECT

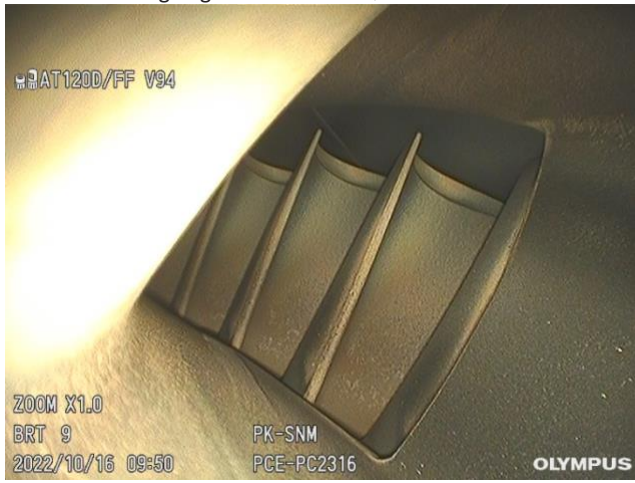
Photo of Leading Edge CT-Blades 1 st Quadrant

5	Perform inspection of CT blades and shroud segments. <u>Defects:</u> RESULT SATISFACTORY FOUND NO DEFECT <u>If defects found, quote MM Limitation and References :</u>	SIGN

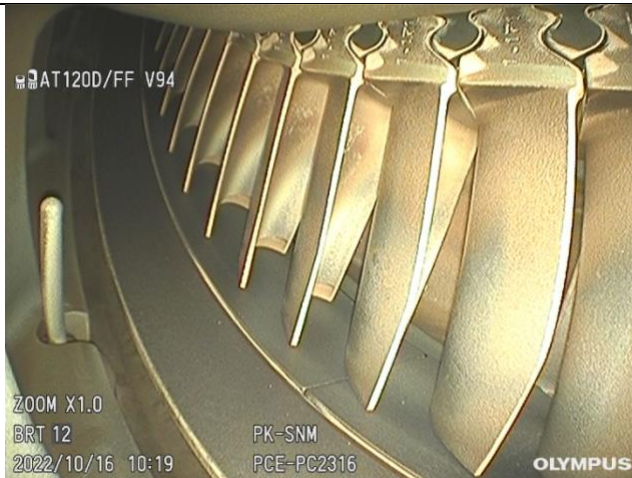
Photo of Trailing Edge CT-Blades 3rd Q

6	Perform inspection trailing edge of CT blades. <u>Defects:</u> RESULT FOUND SATISFACTORY <u>If defects found, quote MM Limitation and References :</u>	SIGN	STAMP

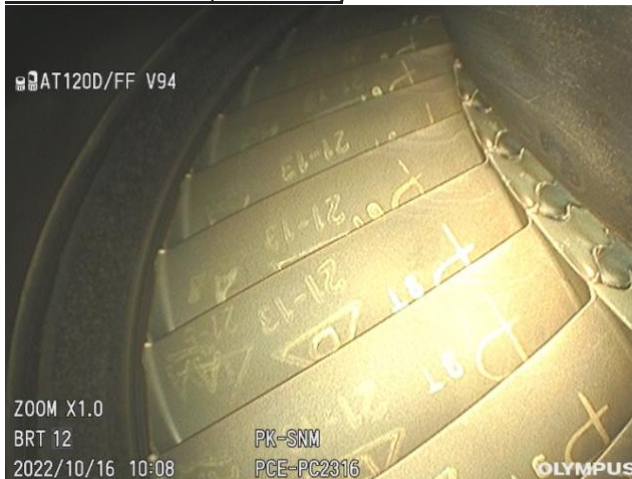
Photo of PT-Blades/Vanes 1st Q

RESULT SATISFACTORY FOUND NO DEFECT
