Subject :	No.	WO/077-PK-SNX/VIII/2023
Inspection 10FH,15FH,30FH & EI-011	Date	18-Aug-2023
	A/C Reg.	PK-SNX EC130T2-8829
Reference :	Prepared By	TS
MP EC 130 T2 Rev. 2	Checked By	CI
	Approved By	TM

1. Perform Inspection 10 FH, 15 FH, 30 FH Add Task EI-011
2. Make an entry in Maintenance Log.
3. Return the Completed Work Order and Form to PPC.

VISUAL INSPECTION OF THE REAR TRANSMISSION BEARING SUPPORT ASB EC130-05A039

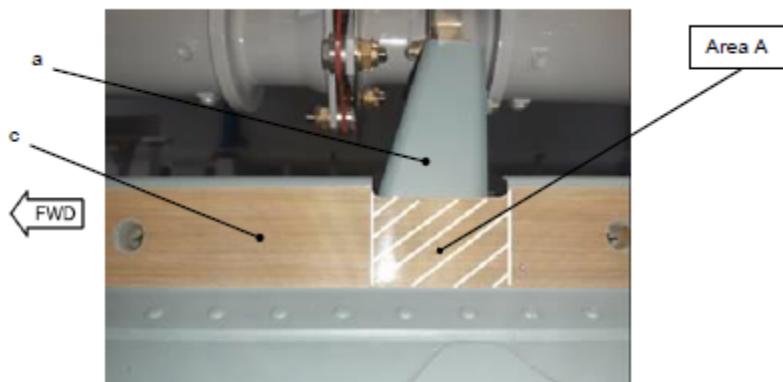
Figure 1

3.B.2.c. Removal of the Teflon tape from the tailboom (Figure 1)

- Unstick the Teflon tape (c) on the hatched area (A).
- Slip a protection (3) (not shown) between the Teflon tape (c) and the tailboom structure.

- Cut and remove the Teflon tape (c) on the hatched area (A) with the cutter (yy) (not shown).

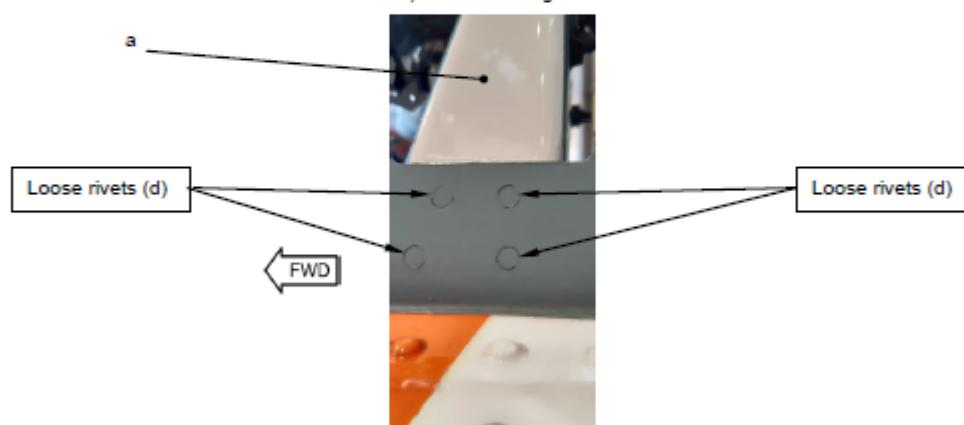
Figure 2

3.B.2.d. Visual inspection of the rivets head of the rear bearing support under the Teflon tape (Figure 2)

A loose rivet is a rivet with black mark or missing paint around the rivet head, refer to the Figure 2.

- Make sure that there is no missing, loose or sheared rivet (d) on the rear transmission bearing support (a) with the light source (zz).
