DOCUMENT FORM BORESCOPE INSPECTION FORM	
		Page 1

Engine Borescope Inspection			
Job No: WO/038-SNH/XII/2021			
<u>Engine Serial Number</u>	<u>Date</u>	<u>Base / Location</u>	<u>Aircraft Registration</u>
PCE-VA0662	20 DEC 2021	NABIRE	PK-SNH
<u>Aircraft Total Time</u>	<u>Aircraft Total Cycle</u>	<u>Reason For Borescope</u>	
1996:08 Hours	2891 Cycle	400 HOURS INSPECTION

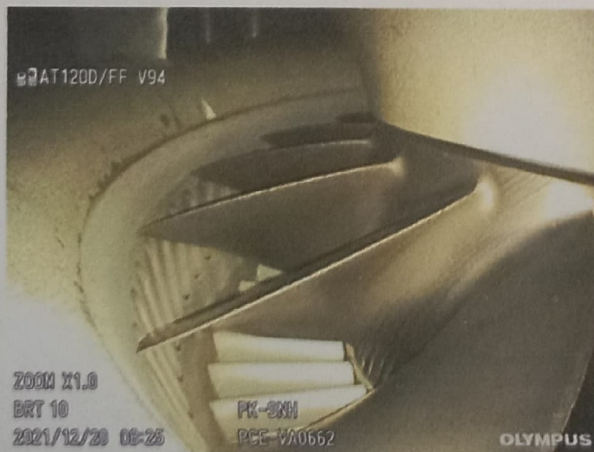
Photo of First Stage Compressor 1st Quadrant

2	Perform inspection of the First Stage Compressor. Defects: RESULT FOUND NO DEFECT <u>If defects found, quote MM Limitation and References :</u>

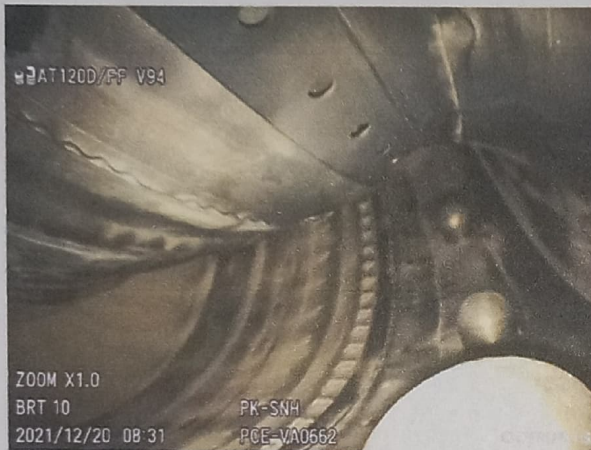
Photo of Combustion Chamber 1st Quadrant

3	Perform inspection of Combustion Chamber Liner Assembly. <u>Defects:</u> Carbon Build Up on some place around cooling hole <u>If defects found, quote MM Limitation and References :</u> PT6A-114A EMM 72-40-00 (ACCEPTABLE CONDITION)	SIGN	STAMP

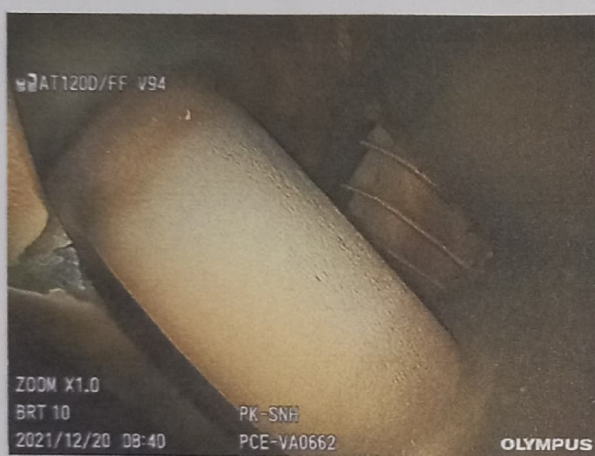
Photo of CT Stator 1st Quadrant

4	Perform Inspection of CT-Stator assembly. <u>Defects:</u> RESULT FOUND MATERIAL LOSS AND INITIAL COATING ON SMALL EXIT DUCT -SERVICEABLE CRITERIA- CONTINUE IN SERVICE <u>If defects found, quote MM Limitation and References :</u> PT6A-140 EMM 72-00-00-280-804	SIGN	STAMP

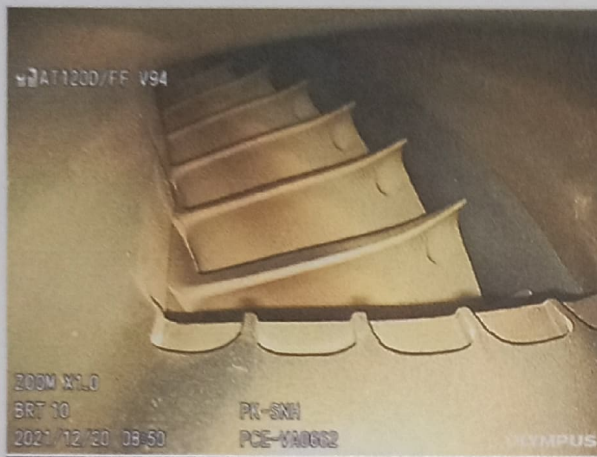
Photo of Leading Edge CT-Blades 1st Quadrant

5	Perform inspection of CT-Blades and shroud segments. Defects: RESULT FOUND NO DEFEECT If defects found, quote MM Limitation and References :	SIGN

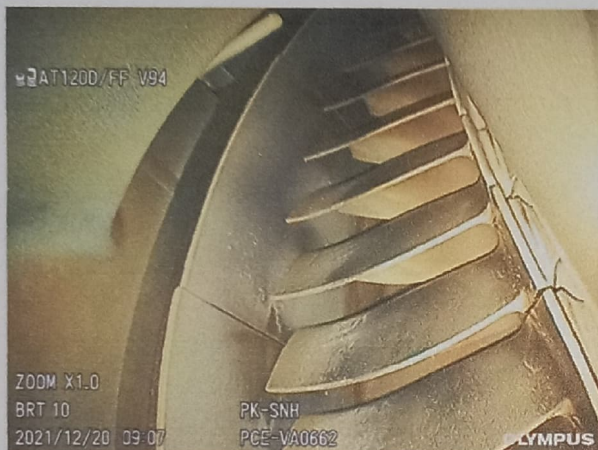
Photo of CT-Blades Trailing Edge 1st

6	Perform inspection CT-Blades Trailing Edge <u>Defects:</u> RESULT SATISFACTORY FOUND NO DEFECT <u>If defects found, quote MM Limitation and References :</u>	SIGN	STAMP

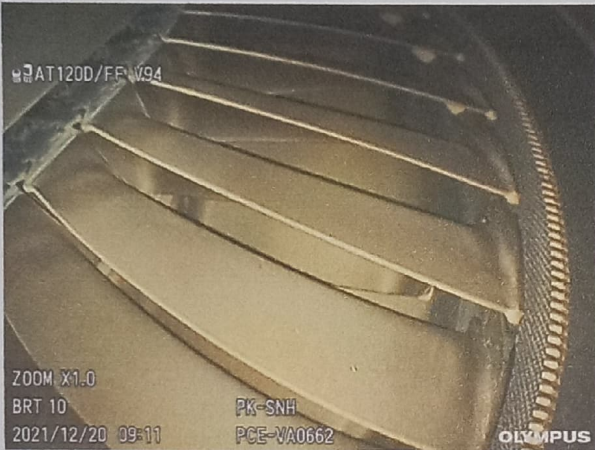
<p style="text-align: center;"><u>Photo of PT-Blades 1st Q</u></p>

7	Perform inspection of PT-Blades <u>Defects:</u> RESULT SATISFACTORY FOUND NO DEFECT <u>If defects found, quote MM Limitation and References :</u>	SIGN
