PT. SMART CAKRAWALA AVIATION

Subject : <b>ASB EC130-05A040</b>	No.	WO/067-PK-SNX/V/2023
	Date	29-May-2023
	A/C Reg.	PK-SNX EC130T2-8829
Reference :  ASB No. EC130-05A040 Rev. 0	Prepared By	TS
	Checked By	CI
	Approved By	TM
To :     Engineer In Charge		
<b>Description :</b>  <ol style="list-style-type: none"><li>1. Perform ASB EC130-05A040 due at : not more than 1160:14 FH</li><li>2. Make an entry in Maintenance Log.</li><li>3. Return the Completed Work Order and Form to PPC.</li></ol> <p>#If any finding, please close the routine card, and transferred to inspection card.</p>		
<b>Additional Work :</b>		
Compliance Statement	Sign & Date Company Lic. No.:  (Engineer In Charge)	Signature  (Technical Manager)

TECHNICAL SUPPORT TECHNICAL DEPARTMENT <b>ENGINEERING INSTRUCTION</b>	019/TEK-TS/V/2023	
		Rev. No	Original
		Rev. Date	29 May 2023

**Alert Service Bulletin (ASB) EC130-05A040**  
**TIME LIMITS - MAINTENANCE CHECKS - Main rotor drive**  
**Check of the Main Gear Box (MGB) bevel wheel**

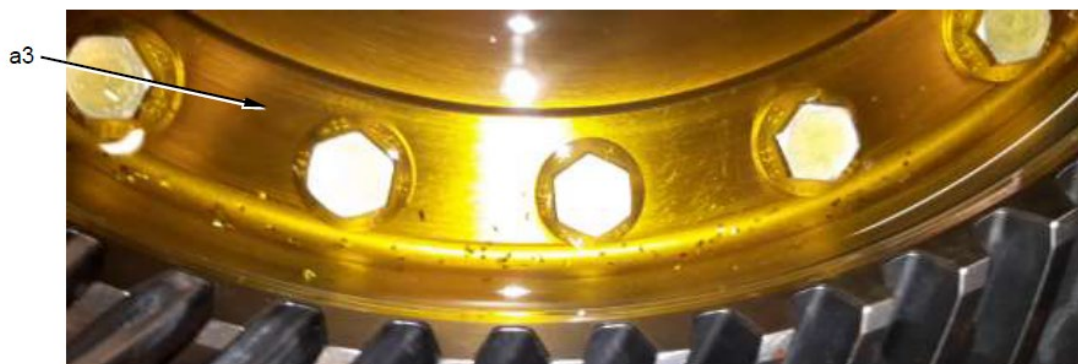
Figure 3

Make sure that there is no particle on the bevel wheel (a3) (Figure 3 and Figure 4).

**Example of the presence of particles**

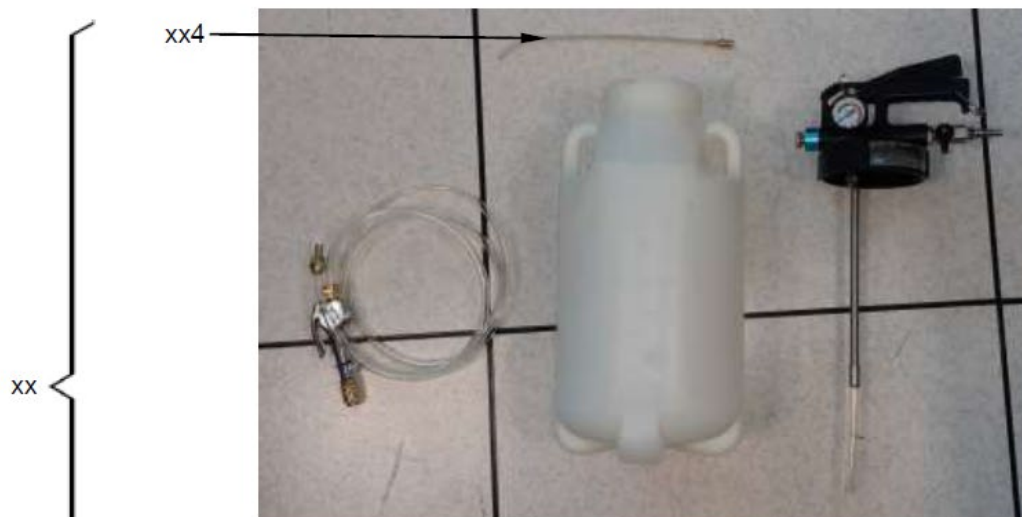
Figure 5

Cut the semi rigid hose (xx4) of the vacuum pump (xx) to a length of 400 mm (15.74 in) (Figures 5 and 6).

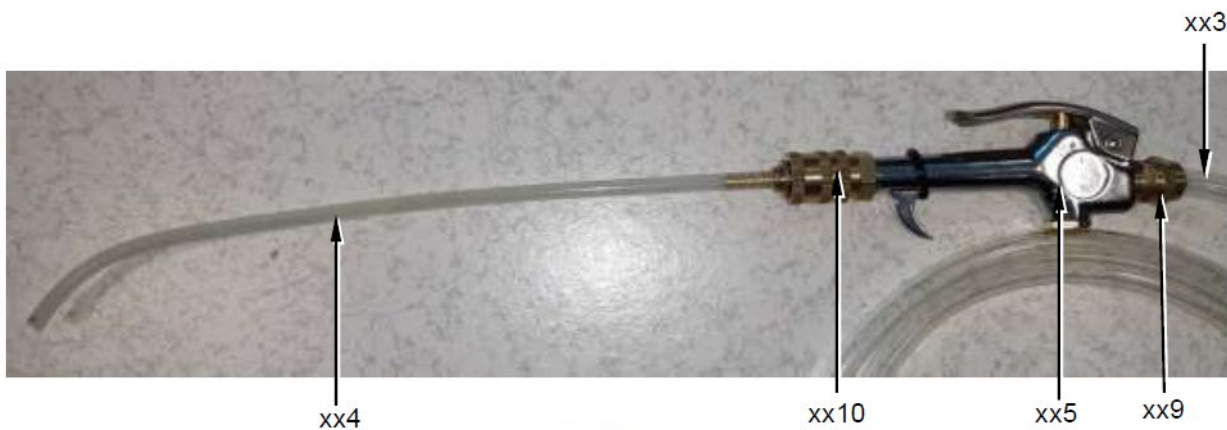
Figure 8

To limit the risk of particles blocked in the pistol grip (xx5), disconnect (Figure 8):

- The pistol grip (xx5).
- The connection (xx10).
- The connection (xx9).

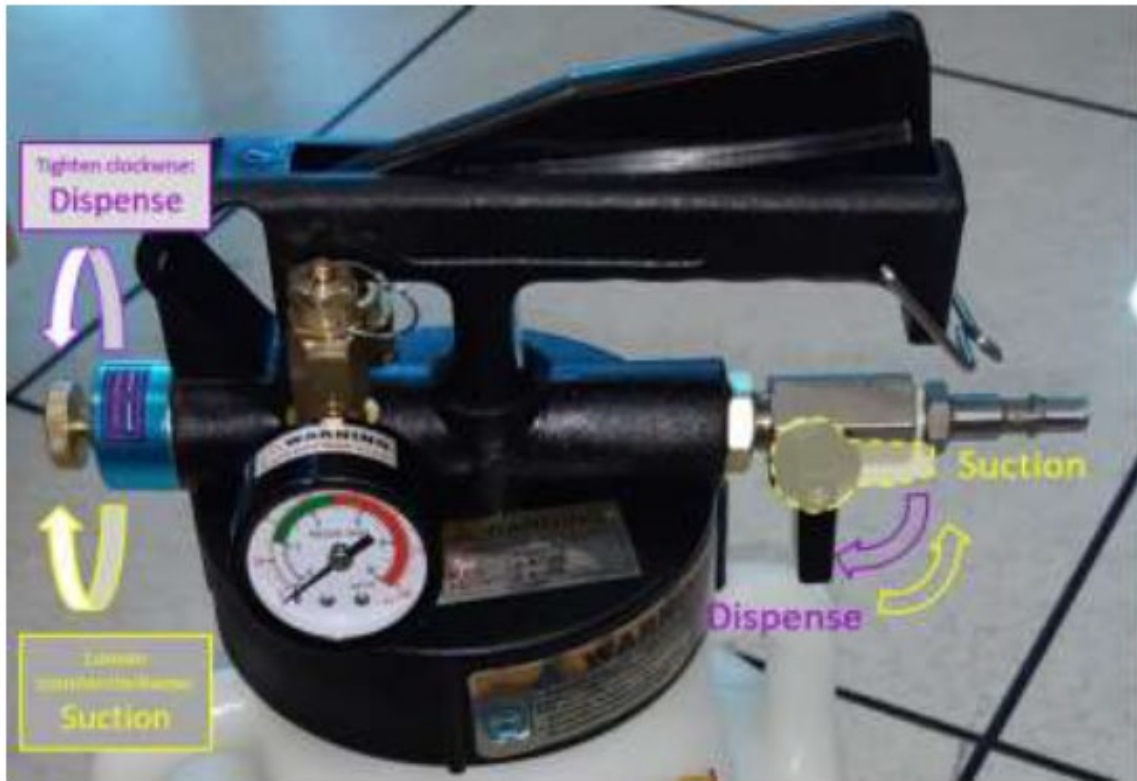
Figure 11

Put the vacuum pump (xx) in suction mode (Figure 11).

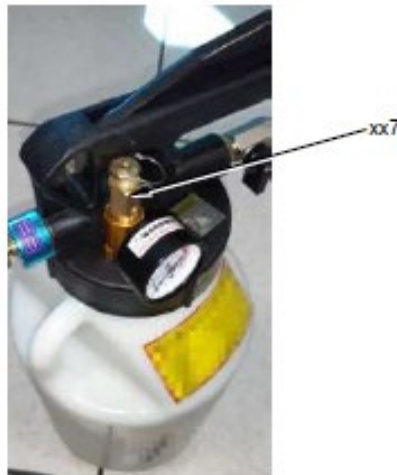
Figure 14

Make sure that there is no remaining pressure with the safety valve (xx7) of the vacuum pump (xx) (Figure 14).
