DOCUMENT FORM
BORESCOPE INSPECTION
FORM

Engine Borescope Inspection

Job No: WO/027-SNG/XII/2021

Engine Serial Number	Date	Base / Location	Aircraft Registration
PCE-VA0596	02 january 2022	NABIRE	PK-SNG
Aircraft Total Time	Aircraft Total Cycle	Reason For Borescope	
1998:52 Hours	3294 Cycle	400 HOURS INSPECTION

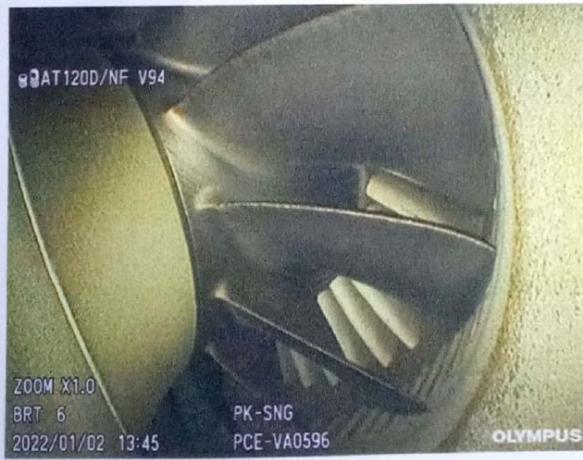
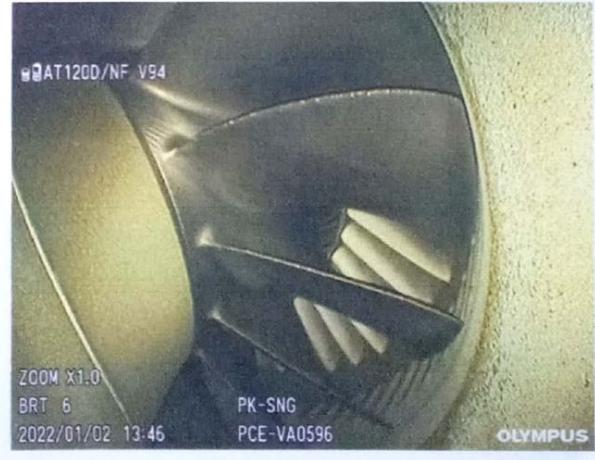
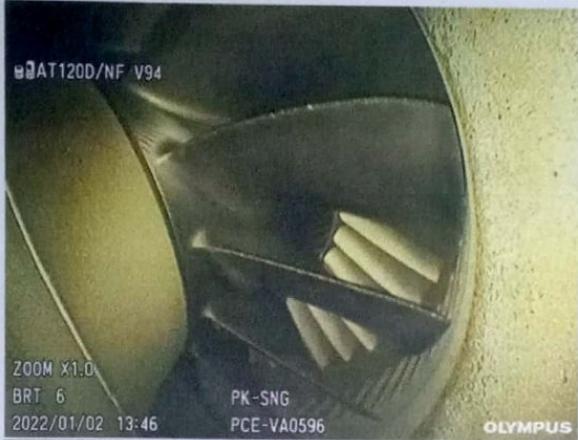
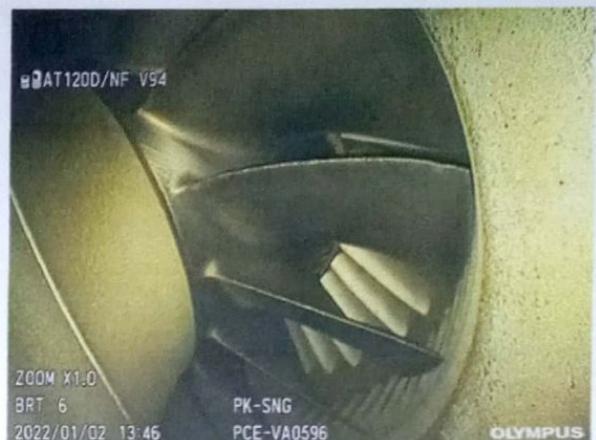
Item	Work Description	SIGN	STAMP
1	Remove fuel manifold adapter as necessary (Ref. 73-10-05).		
2	Perform inspection of the First Stage Compressor. Defects: <u>RESULT FOUND NO DEFECT</u> <u>If defects found, quote MM Limitation and References :</u>

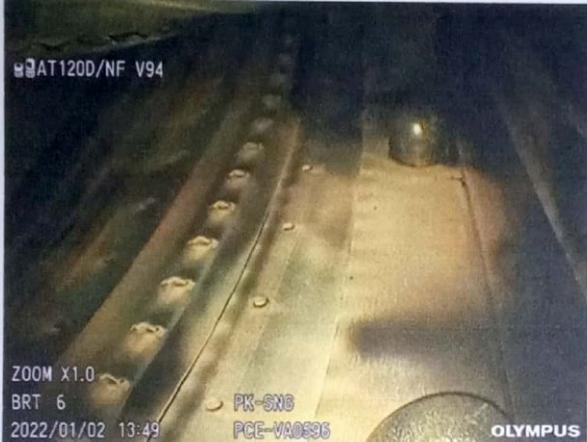
<p><u>Photo of Combustion Chamber 1st Quadrant</u></p>

3	Perform inspection of Combustion Chamber Liner Assembly. <u>Defects:</u> Carbon Build Up on some place around cooling hole <u>If defects found, quote MM Limitation and References :</u> PT6A-140 EMM 72-40-00 (Acceptable Conditions)	SIGN	STAMP
---	--	------	-------

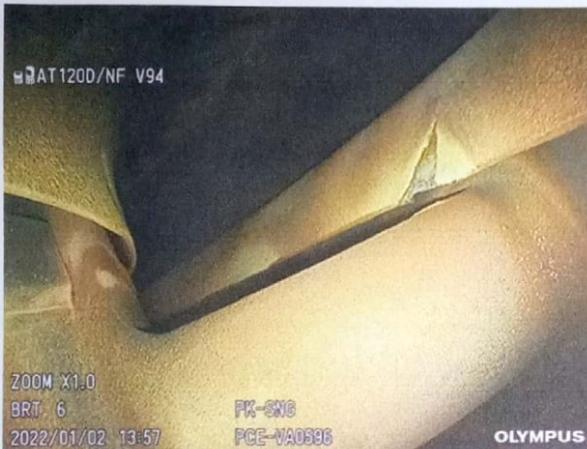
<u>Photo of CT Stator 1st Quadrant</u>

4	Perform Inspection of CT-Stator assembly. <u>Defects:</u> RESULT FOUND LOSS COATING AND MATERIAL ON SMALL EXIT DUCT – SERVICEABLE CRITERIA- CONTINUE IN SERVICE <u>If defects found, quote MM Limitation and References :</u> PT6A-140 EMM 72-00-00-280-804	SIGN	STAMP
---	--	------	-------

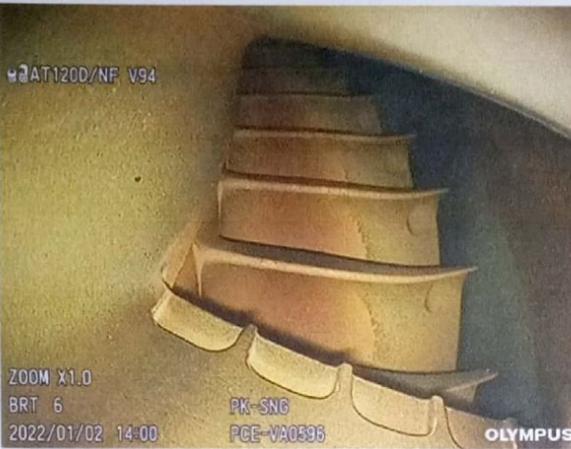
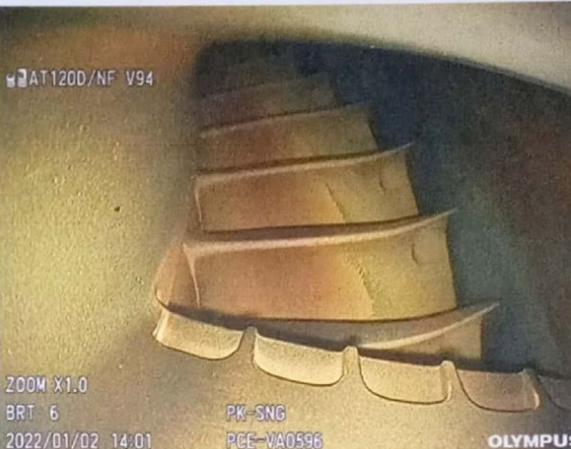
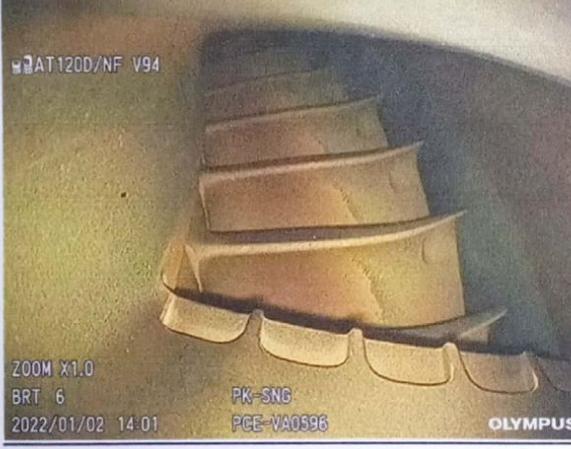
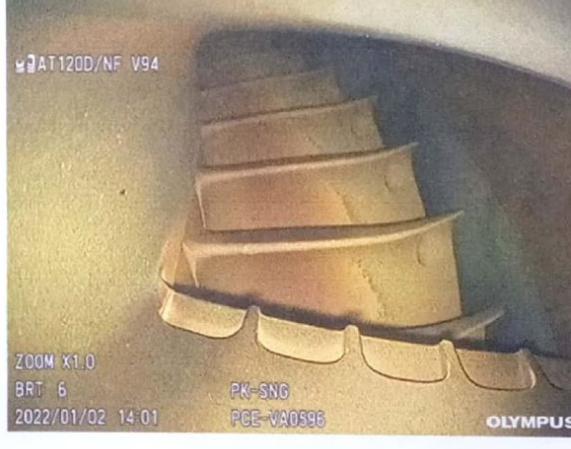
5	<p>Perform inspection of CT-Blades and shroud segments. <u>Defects:</u> <u>RESULT FOUND NO DEFFECT</u> <u>If defects found, quote MM Limitation and References :</u></p>	<p>SIGN</p>

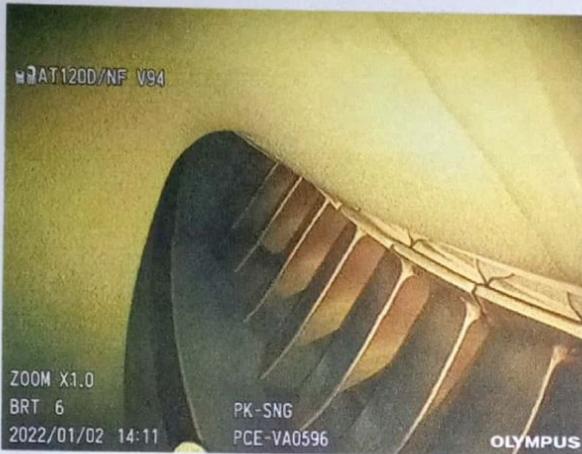
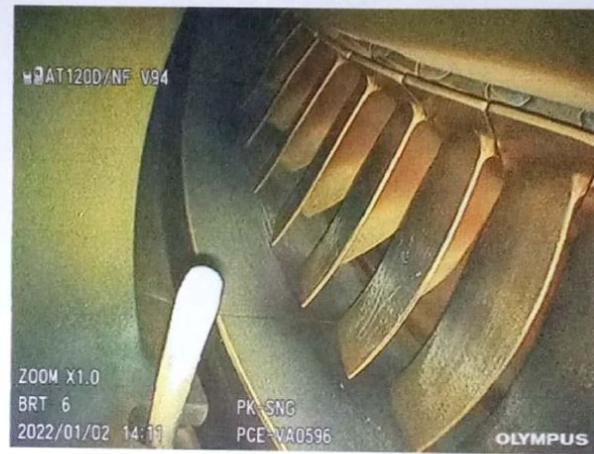
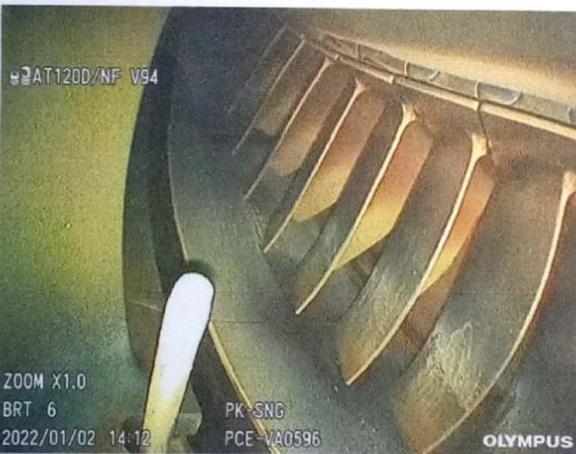
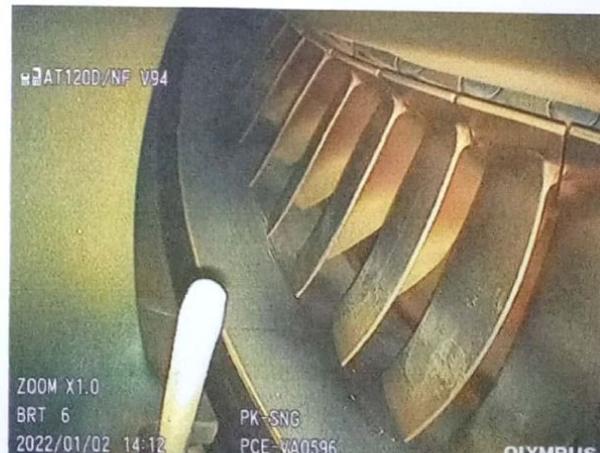
6	<p>Perform inspection CT-Blades Trailing Edge <u>Defects:</u> RESULT SATISFACTORY FOUND NO DEFECT <u>If defects found, quote MM Limitation and References :</u></p>	SIGN	STAMP
