**DOCUMENT FORM
BORESCOPE INSPECTION
FORM**

Engine Borescope Inspection

Job No: **WO/064-SNK/XI/2021**

<u>Engine Serial Number</u>	<u>Date</u>	<u>Base / Location</u>	<u>Aircraft Registration</u>
PCE-PC2327	15 NOVEMBER 2021	NABIRE	PK-SNK
<u>Aircraft Total Time</u>	<u>Aircraft Total Cycle</u>	<u>Reason For Borescope</u>	
3166:18 Hours	4453 Cycle	1600 HOURS INSPECTION

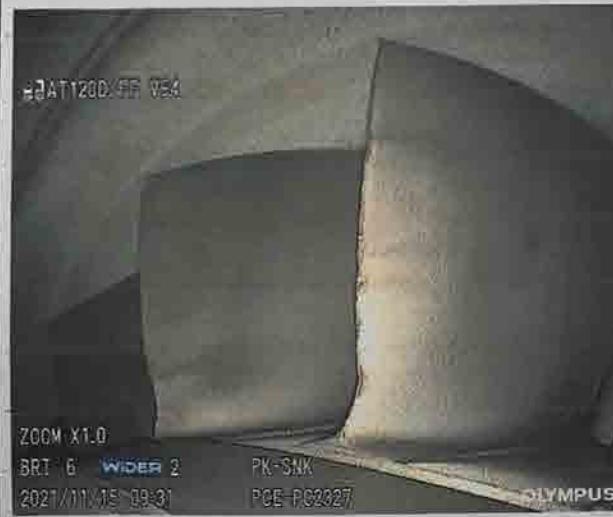
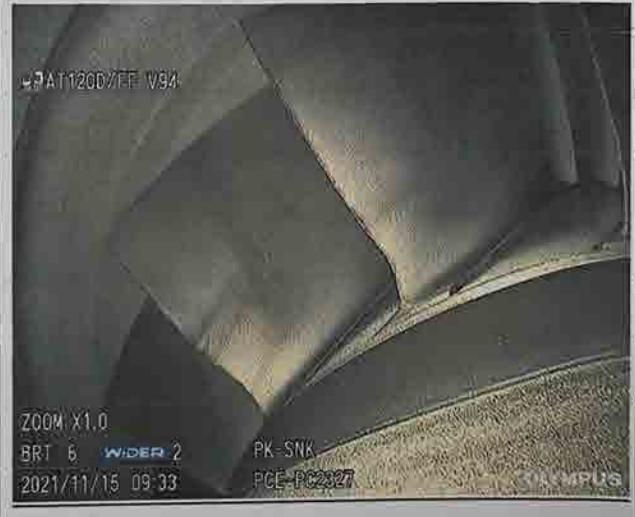
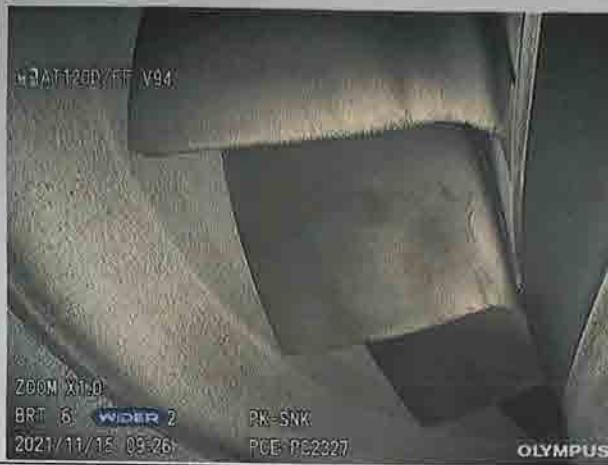
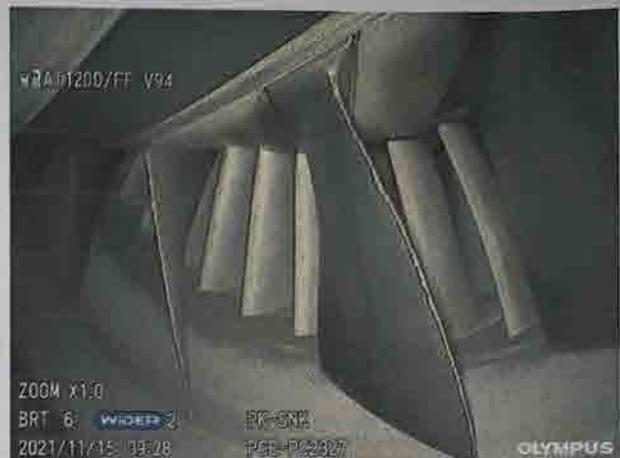
Item	Work Description	SIGN	STAMP
1	Remove fuel manifold adapter as necessary (Ref. 73-10-05).		
2	Perform inspection of the First Stage Compressor. Defects: EROSION AT LEADING EDGE ROTOR <u>If defects found, quote MM Limitation and References:</u> PT6A-114A EMM 72-30-05 Para. 5.C & 5.D (Acceptable Conditions, Repair Unnecessary)

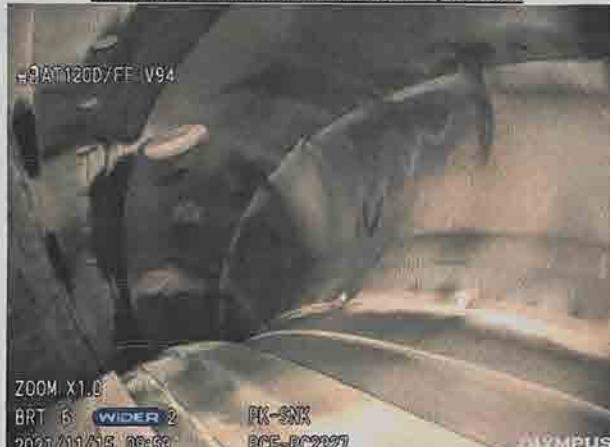
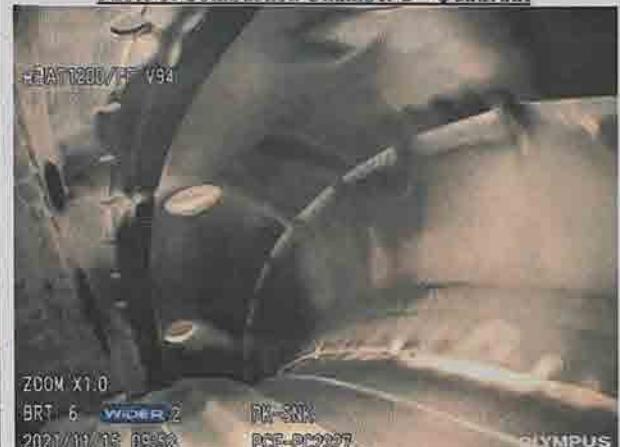
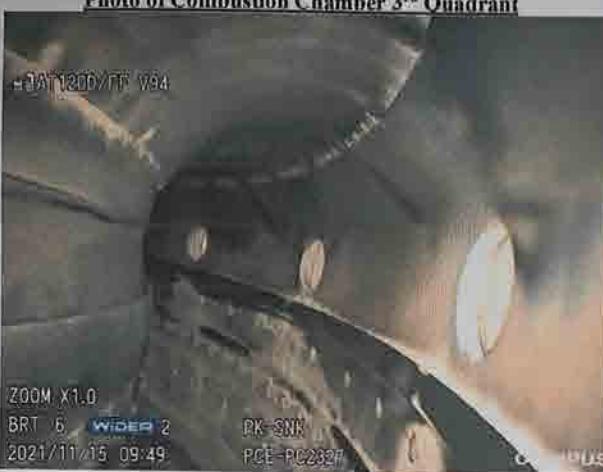
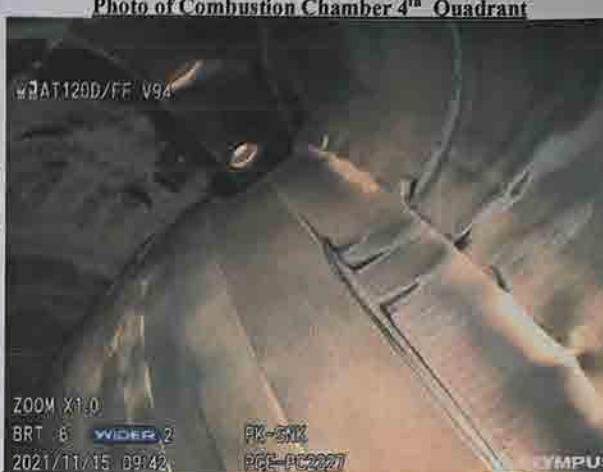
Localized Burning and Carbon build up of the Cooling Ring

PT6A-114A EMM 72-40-01 Para. 6.B (Acceptable Conditions, Repair Unnecessary)

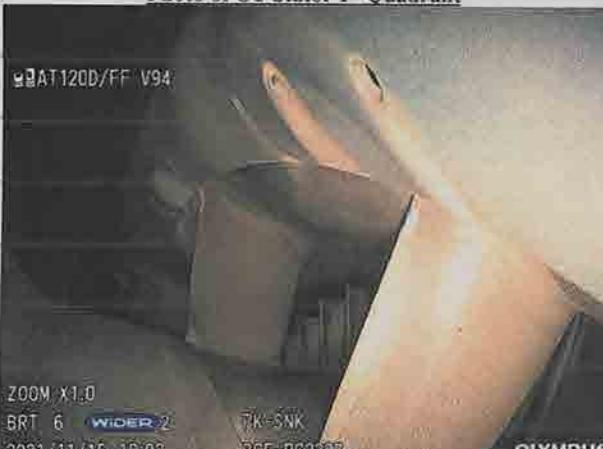
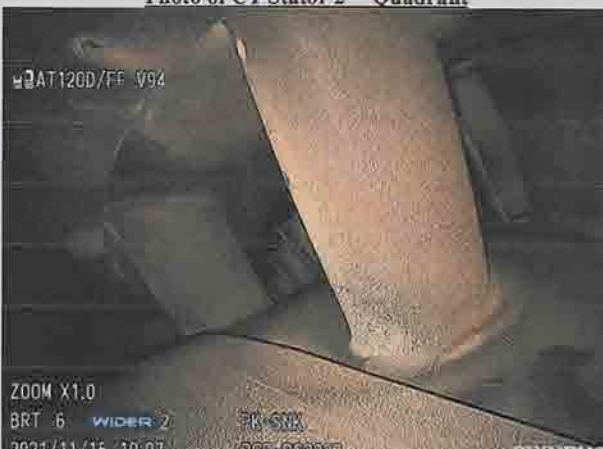
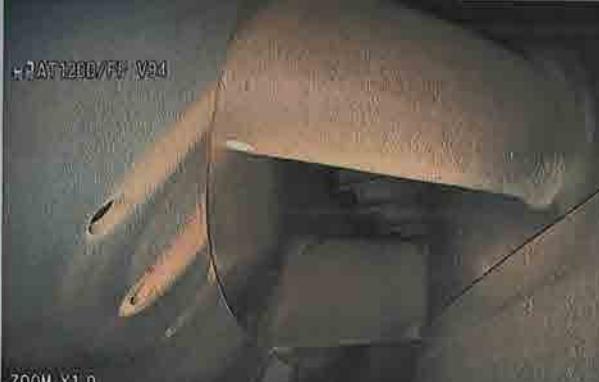
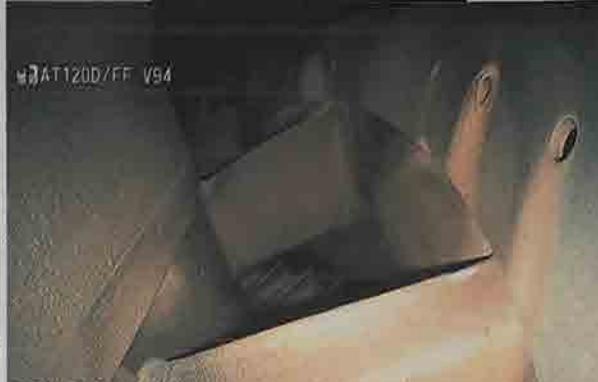
<p>#3AT120D/FF V94</p> <p>ZOOM X1.0 BRT 6 WIDER 2 2021/11/15 09:42</p> <p>PK-SNK PCE-PC2327</p> <p>OLYMPUS</p>	
4	<p>Perform Inspection of CT-Stator assembly. <u>Defects:</u> RESULT FOUND NO DEFECT <u>If defects found, quote MM Limitation and References:</u></p>	SIGN	STAMP

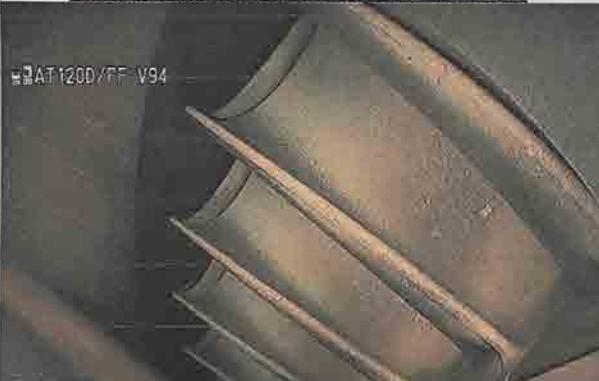
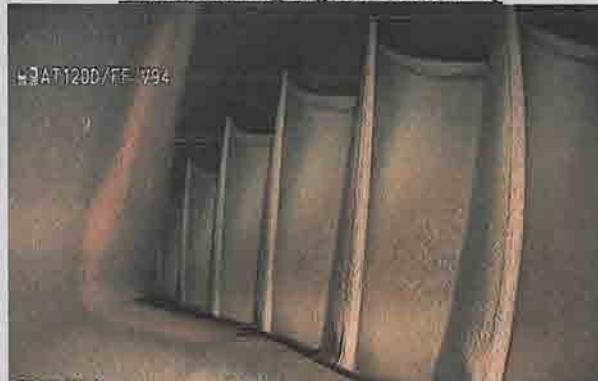
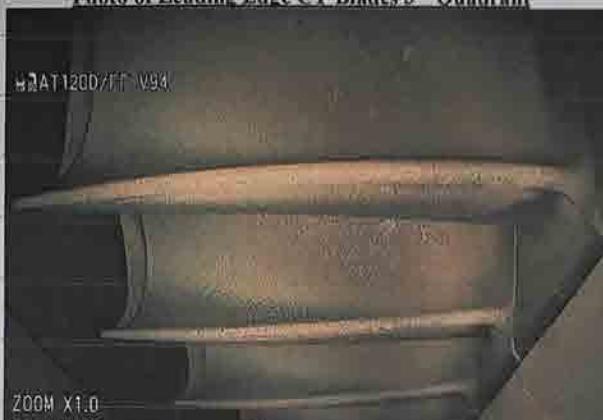
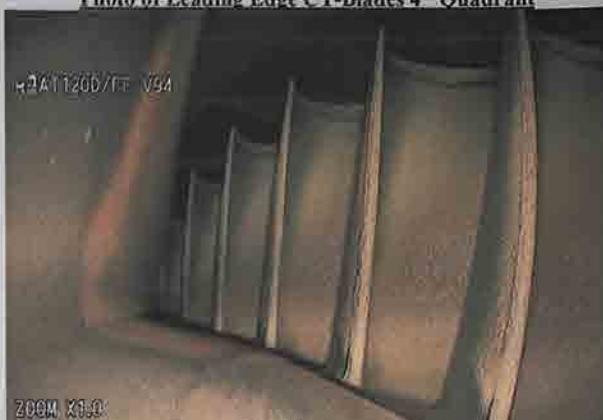
<p>#3AT120D/FF V94</p> <p>ZOOM X1.0 BRT 6 WIDER 2 2021/11/15 09:57</p> <p>PK-SNK PCE-PC2327</p> <p>OLYMPUS</p>	
5	<p>Perform inspection of CT-Blades and shroud segments. <u>Defects:</u> RESULT FOUND NO DEFECT</p> <p>If defects found, quote MM Limitation and References:</p>		<p>SIGN</p>

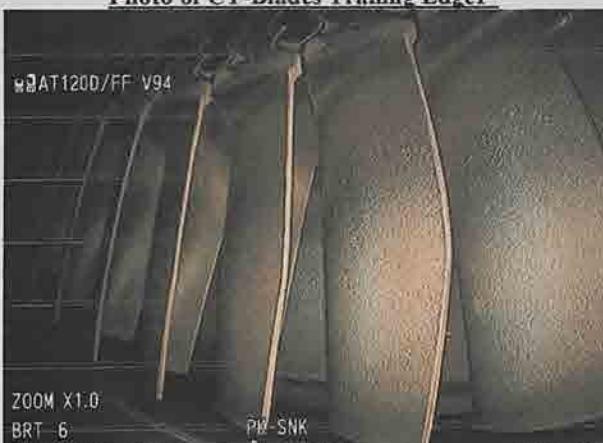
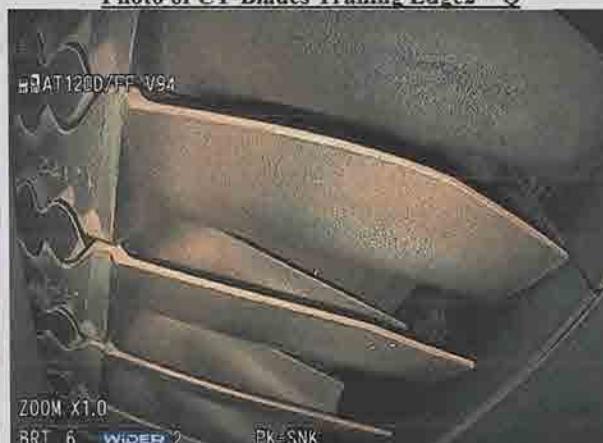
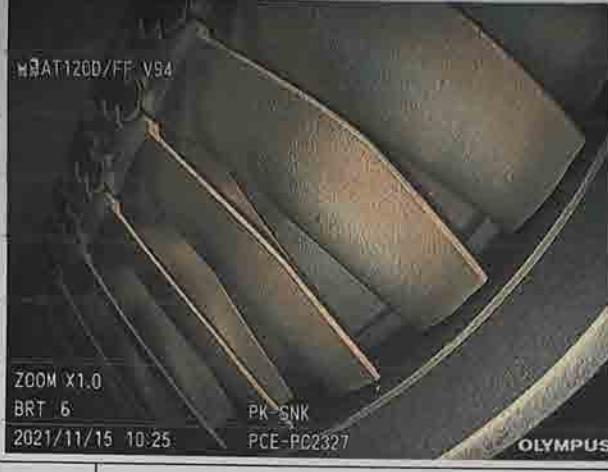
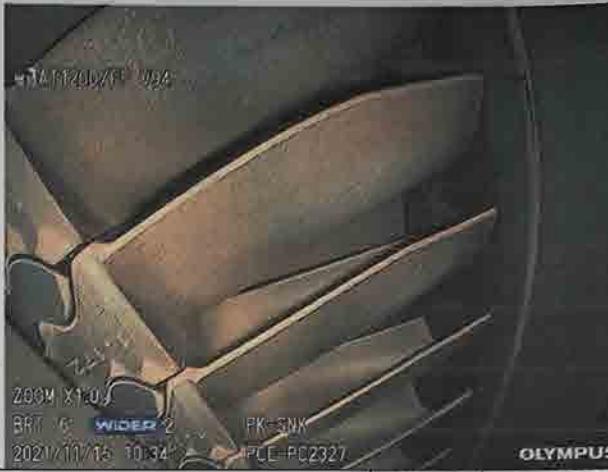
<p>ZOOM X1.0 BRT 6 WIDER 2 2021/11/15 10:07 PK-SNK PCE-PC2327</p> <p>OLYMPUS</p>	
6	<p>Perform inspection CT-Blades Trailing Edge Defects: RESULT SATISFACTORY FOUND NO DEFECT</p> <p>If defects found, quote MM Limitation and References:</p>	SIGN	STAMP
<p>Photo of CT-Blades Trailing Edge 1st</p>

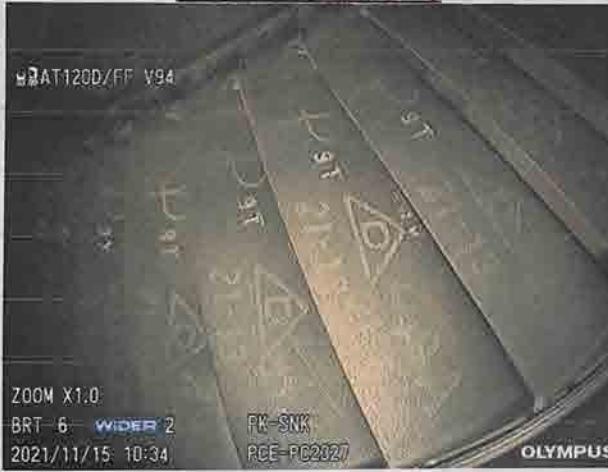
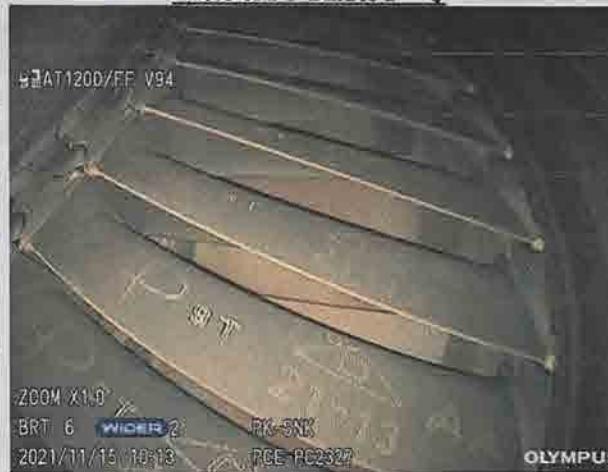
<p>W3AT120D/FF V94</p> <p>ZOOM X1.0</p> <p>BRT 6</p> <p>2021/11/15 10:25</p> <p>PK-SNK</p> <p>PCE-PC2327</p> <p>OLYMPUS</p>		<p>W3AT120D/FF V94</p> <p>ZOOM X1.0</p> <p>BRT 6</p> <p>2021/11/15 10:34</p> <p>WIDER 2</p> <p>PK-SNK</p> <p>PCE-PC2327</p> <p>OLYMPUS</p>	
7	<p>Perform inspection of PT-Blades Defects:</p> <p>RESULT FOUND NO DEFECT</p> <p>If defects found, quote MM Limitation and References:</p>	SIGN	STAMP
Photo of PT-Blades 1st Q		Photo of PT-Blades 2nd Q
