<b>DOCUMENT FORM BORESCOPE INSPECTION FORM</b>	Page   1

Engine Borescope Inspection			
Job No: WO/076-SNK/IV/2022			
<u>Engine Serial Number</u>	<u>Date</u>	<u>Base / Location</u>	<u>Aircraft Registration</u>
PCE-PC2327	30 APRIL 2022	NABIRE	PK-SNK
<u>Aircraft Total Time</u>	<u>Aircraft Total Cycle</u>	<u>Reason For Borescope</u>	
3568:07 Hours	5171 Cycle	400 HOURS INSPECTION

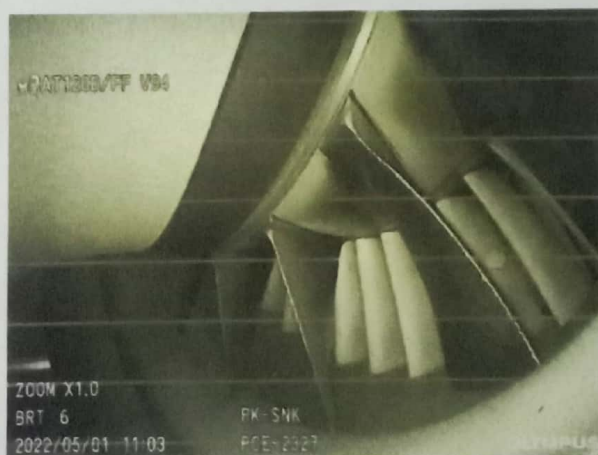
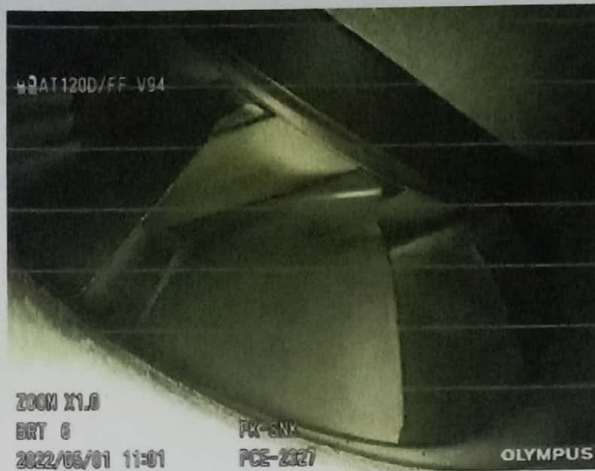
2	Perform inspection of the First Stage Compressor. Defects:  <b>EROSION AT LEADING EDGE WITHIN LIMITATION</b>  <u>If defects found, quote MM Limitation and References:</u> <b>PT6A-114A EMM 72-30-05 Para. 5.C &amp; 5.D (Acceptable Conditions, Repair Unnecessary)</b>

Photo of First Stage Compressor 1<sup>st</sup> Quadrant

Photo of First Stage Compressor 2<sup>nd</sup> Quadrant

**Photo of First Stage Compressor 3<sup>rd</sup> Quadrant**

**Photo of First Stage Compressor 4<sup>th</sup> Quadrant**

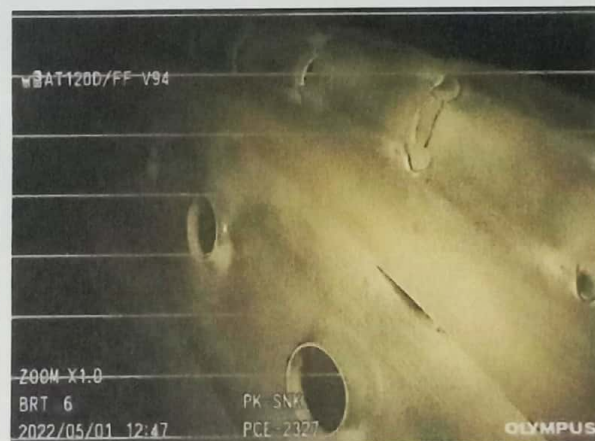
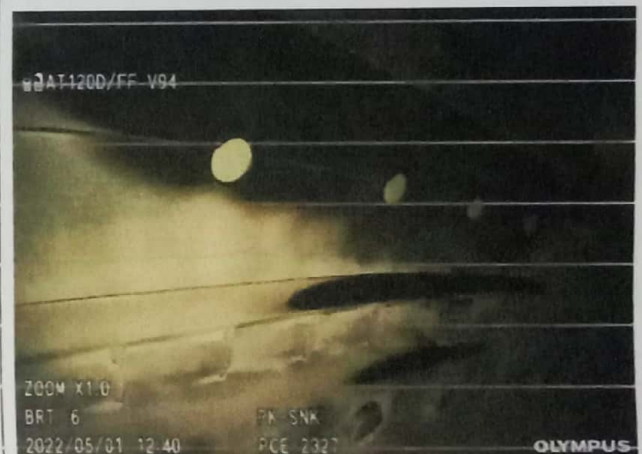
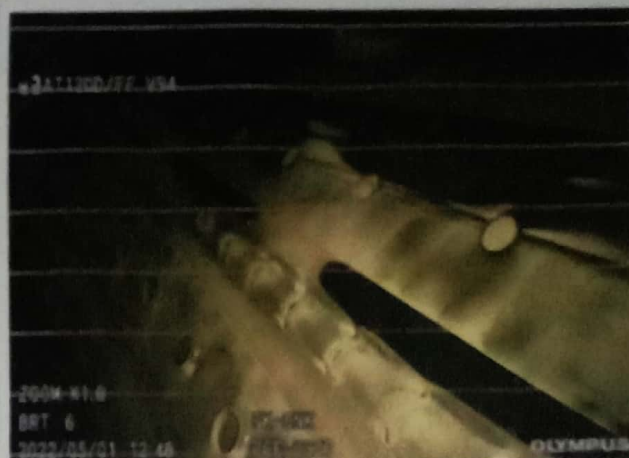
Perform inspection of Combustion Chamber Liner Assembly.  
Defects:

**Localized Burning and Carbon build up of the Cooling Ring**

**PT6A-114A EMM 72-40-01 Para. 6.B (Acceptable Conditions, Repair Unnecessary)**

**Photo of Combustion Chamber 1<sup>st</sup> Quadrant**

**Photo of Combustion Chamber 2<sup>nd</sup> Quadrant**

Photo of Combustion Chamber 3<sup>rd</sup> Quadrant

Photo of Combustion Chamber 4<sup>th</sup> Quadrant

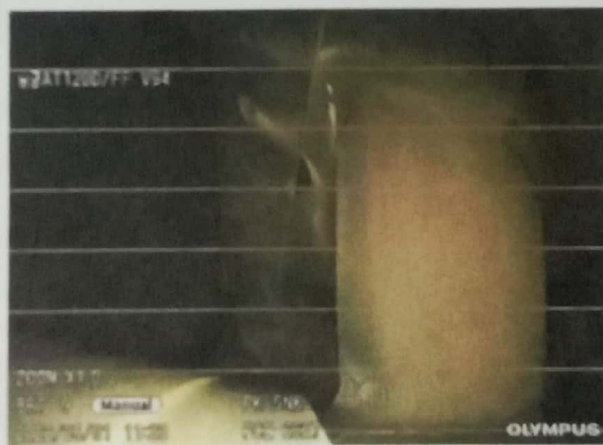
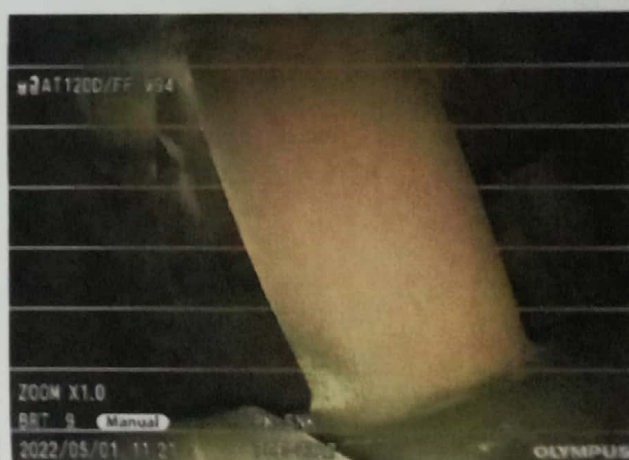
Perform Inspection of CT-Stator assembly.

**RESULT FOUND NO DEFECT**

Photo of CT Stator 1<sup>st</sup> Quadrant

Photo of CT Stator 2<sup>nd</sup> Quadrant

Photo of CT Stator 3<sup>rd</sup> Quadrant

Photo of CT Stator 4<sup>th</sup> Quadrant

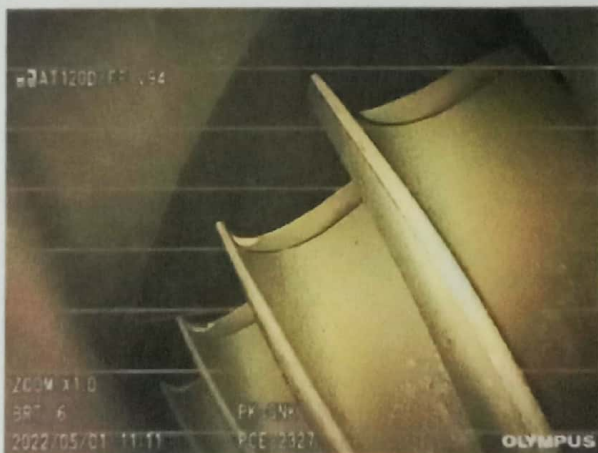
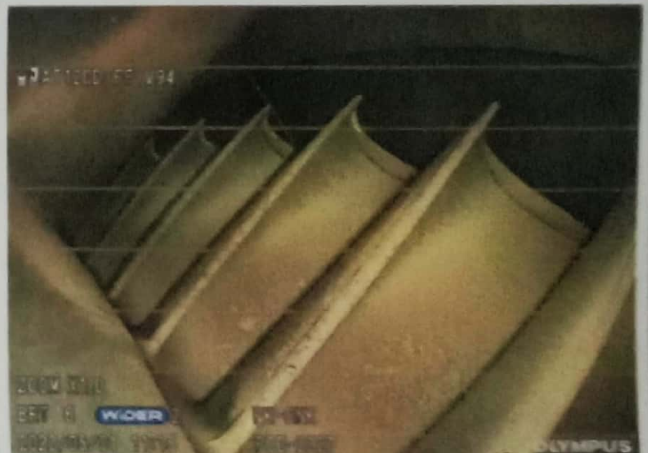
Perform inspection of CT-Blades and shroud segments.

**RESULT FOUND NO DEFECT**

Photo of Leading Edge CT-Blades 1<sup>st</sup> Quadrant

Photo of Leading Edge CT-Blades 2<sup>nd</sup> Q

Photo of Leading Edge CT-Blades 3<sup>rd</sup> Quadrant

Photo of Leading Edge CT-Blades 4<sup>th</sup> Quadrant

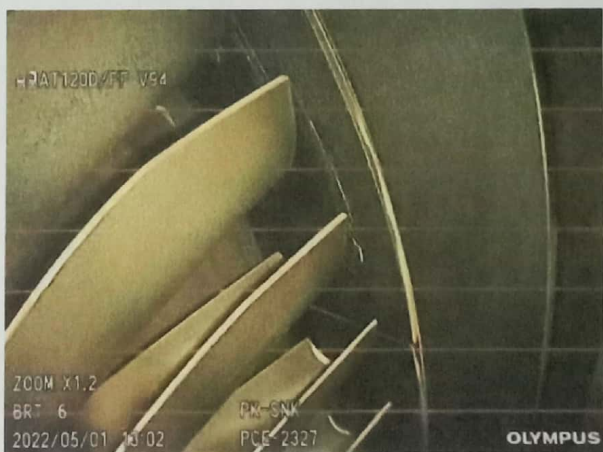
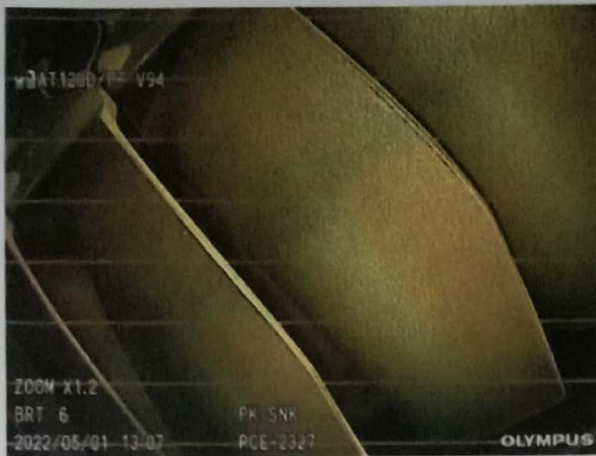
Perform inspection CT-Blades Trailing Edge Defects:

**FOUND SCRATCH ON SHROUD SEGMENT**

**PT6A-114A EMM, 72-50-02, Para.6A (Acceptable Damage Limit)**

Photo of CT-Blades Trailing Edge1<sup>st</sup>

Photo of CT-Blades Trailing Edge2<sup>nd</sup> Q

**Photo of CT-Blades Trailing Edge 3<sup>rd</sup> Q**

**Photo of CT-Blades Trailing Edge 4<sup>th</sup> Q**

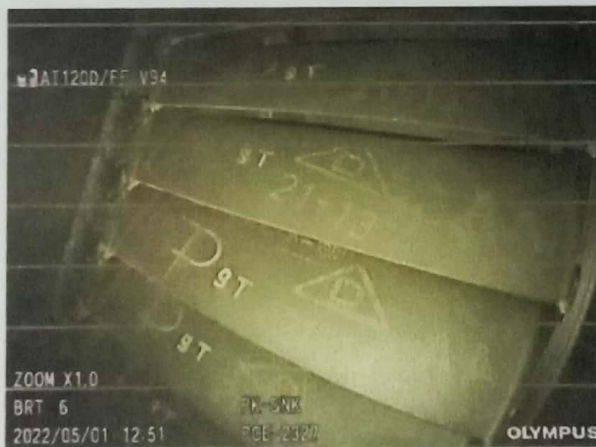
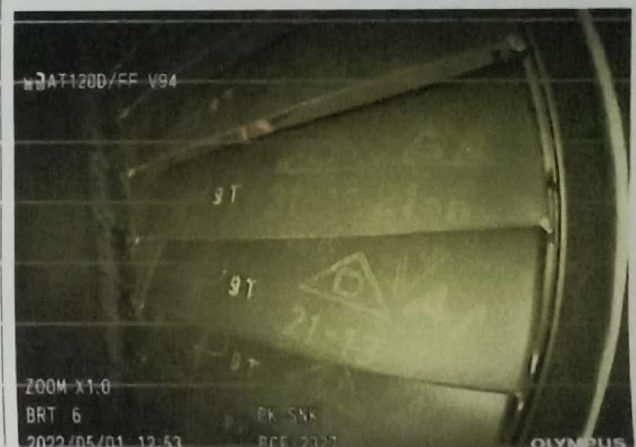
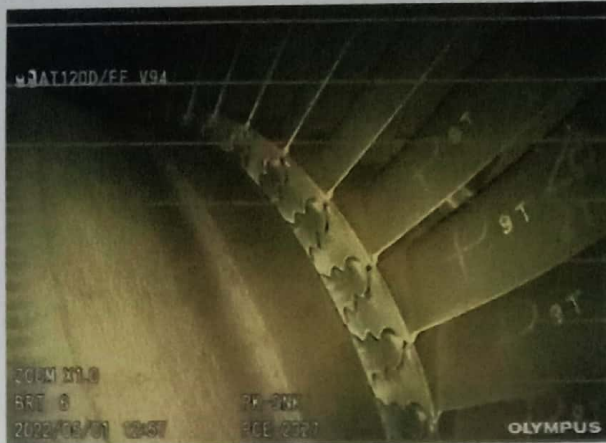
Perform inspection of PT-Blades  
Defects:

**RESULT FOUND NO DEFECT**

**Photo of PT-Blades 1<sup>st</sup> Q**

**Photo of PT-Blades 2<sup>nd</sup> Q**

Photo of PT-Blades 3<sup>rd</sup> O

Photo of PT-Blades 4<sup>th</sup> O
