# DOCUMENT FORM BORESCOPE INSPECTION FORM

Engine Borescope Inspection

Job No: **WO/085-SNM/I/2022**

| <u>Engine Serial Number</u><br><b>PCE-PC2316</b> | <u>Date</u><br><b>05 FEBRUARI 2021</b> | <u>Base / Location</u><br><b>NABIRE</b> | <u>Aircraft Registration</u><br><b>PK-SNM</b> |

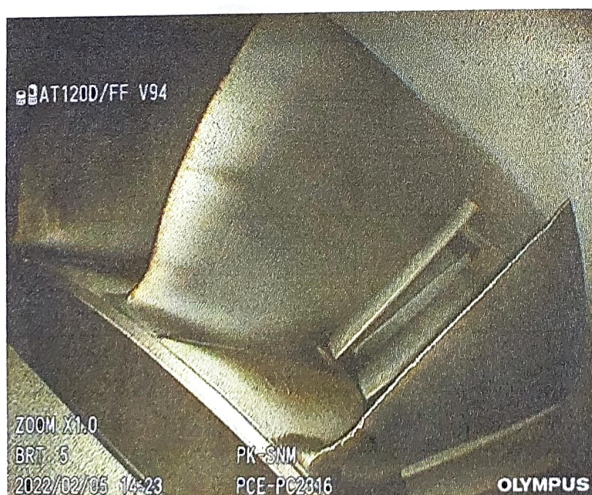
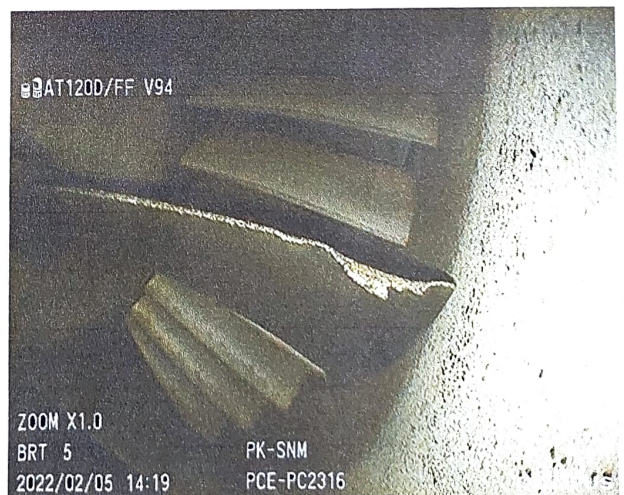
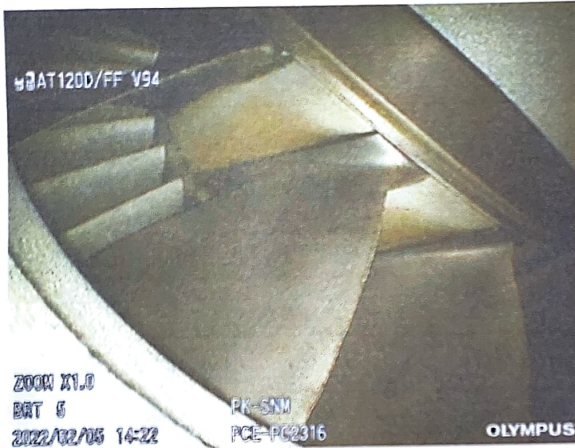
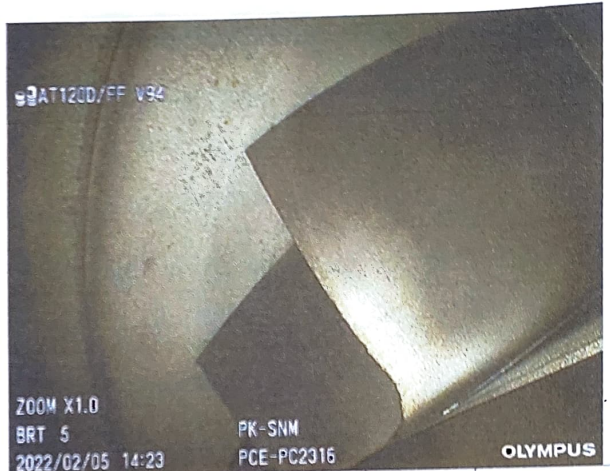
| Item | Work Description | SIGN | STAMP |
|---|---|---|---|
| 2 | <p>Perform inspection of the First Stage Compressor.</p> <p>Defects:<br/><b>EROSION AND SMALL BENT AT LEADING EDGE ROTOR</b></p> <p><u>If defects found, quote MM Limitation and References :</u><br/><b>PT6A-114A EMM 72-30-05 Para. 5.C &amp; 5.D (Acceptable Conditions, Repair Unnecessary)</b></p> | | |

Photo of First Stage Compressor 1<sup>st</sup> Quadrant

Photo of First Stage Compressor 2<sup>nd</sup> Quadrant

Photo of First Stage Compressor 3<sup>rd</sup> Quadrant

Photo of First Stage Compressor 4<sup>th</sup> Quadrant

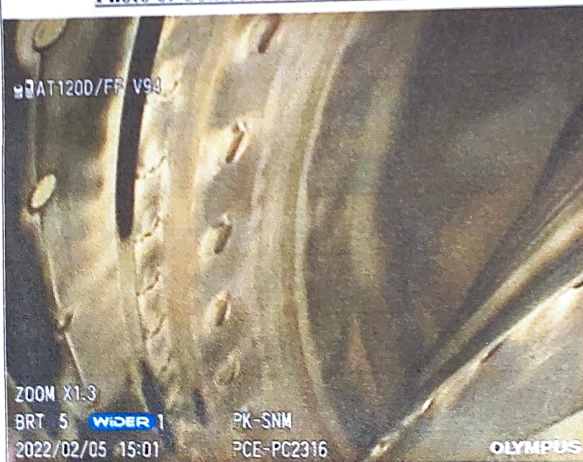
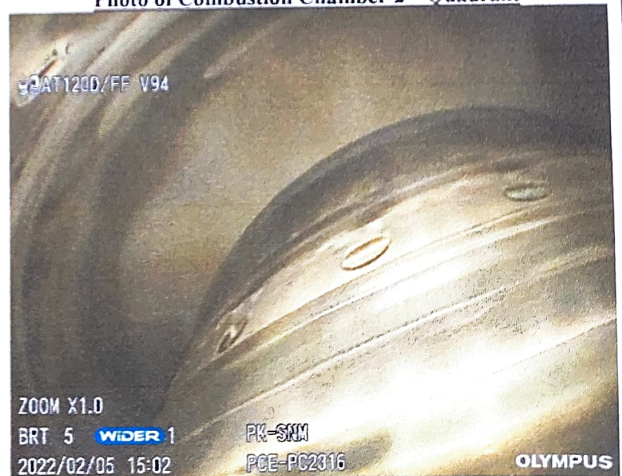
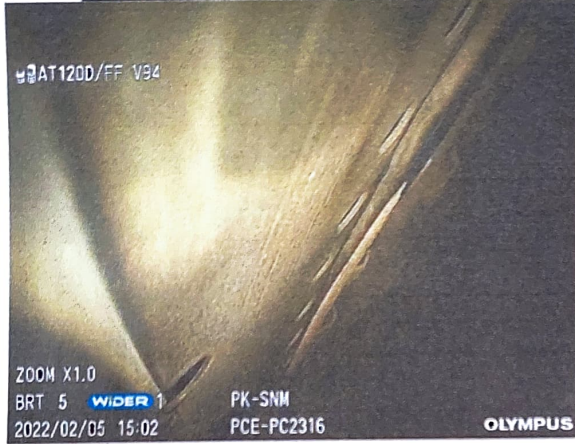
Perform inspection of Combustion Chamber Liner Assembly.

**Localized burning and carbon build up of the cooling ring**

**PT6A-114A EMM 72-40-01 Para. 6.B (Acceptable Conditions, Repair Unnecessary)**

Photo of Combustion Chamber 1<sup>st</sup> Quadrant

Photo of Combustion Chamber 2<sup>nd</sup> Quadrant

Photo of Combustion Chamber 3<sup>rd</sup> Quadrant

Photo of Combustion Chamber 4<sup>th</sup> Quadrant

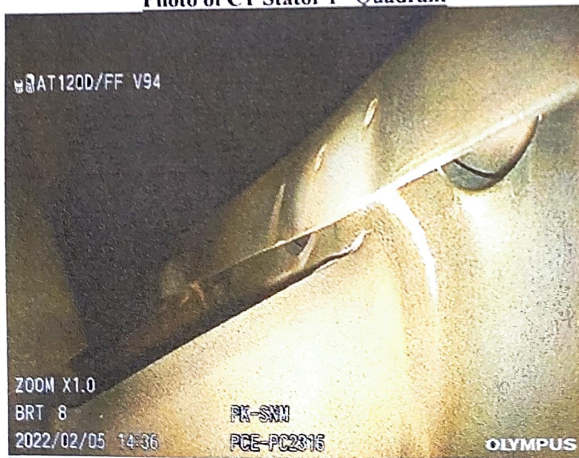
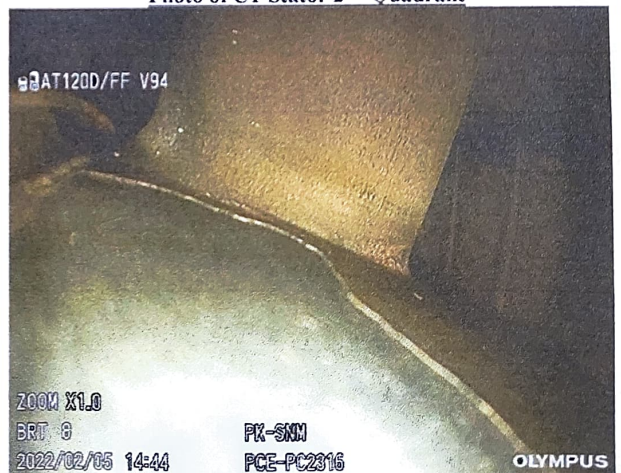
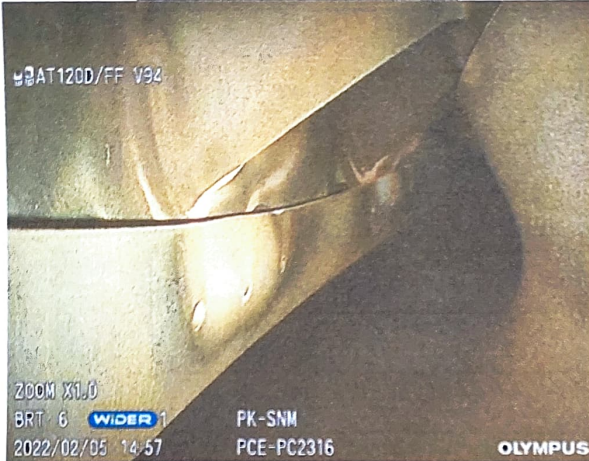
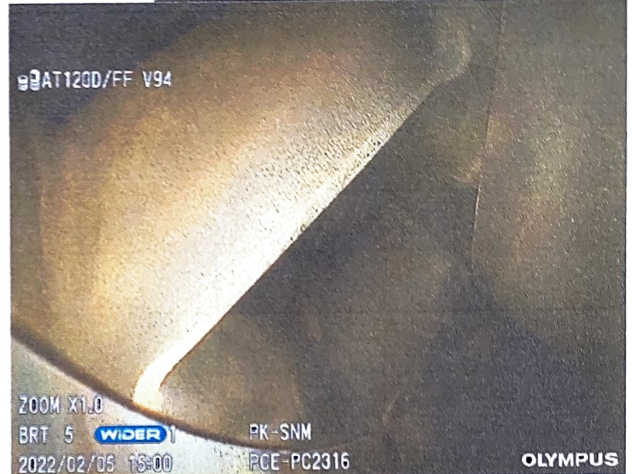
Perform Inspection of CT-Stator assembly.  
Defects:

**RESULT COATING LOSS**

**PT6A-114A EMM 72-50-01 Para. 6. Table 201 (Acceptable Conditions,  
Repair Unnecessary)**

Photo of CT Stator 1<sup>st</sup> Quadrant

Photo of CT Stator 2<sup>nd</sup> Quadrant

Photo of CT Stator 3<sup>rd</sup> Quadrant

Photo of CT Stator 4<sup>th</sup> Quadrant

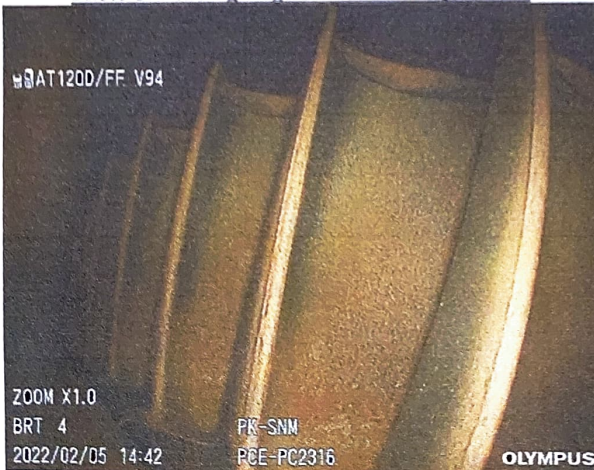
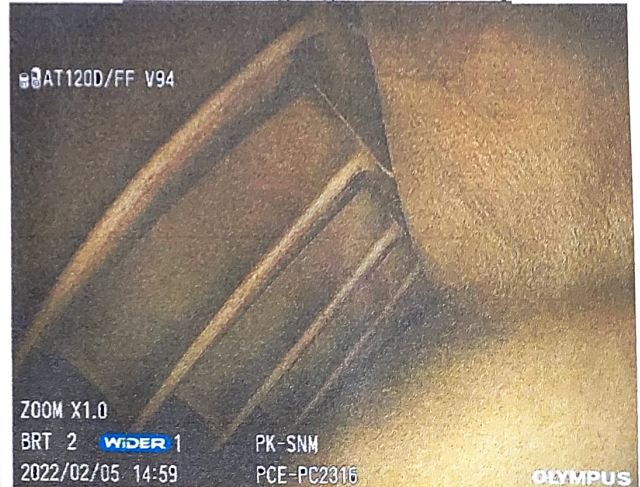
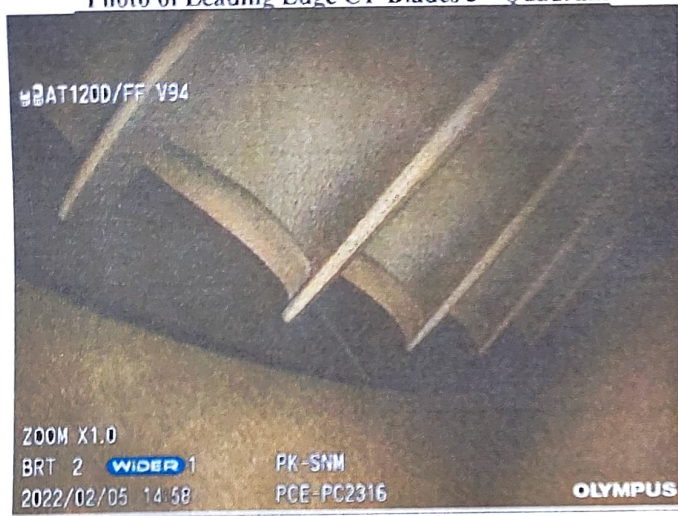
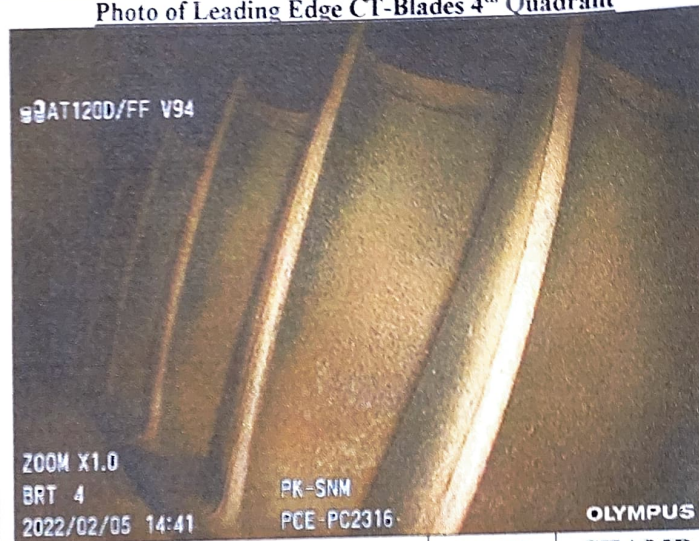
Perform inspection of CT-Blades and shroud segments.

**RESULT FOUND NO DEFECT**

Photo of Leading Edge CT-Blades 1<sup>st</sup> Quadrant

Photo of Leading Edge CT-Blades 2<sup>nd</sup> Q

Photo of Leading Edge CT-Blades 3<sup>rd</sup> Quadrant

Photo of Leading Edge CT-Blades 4<sup>th</sup> Quadrant

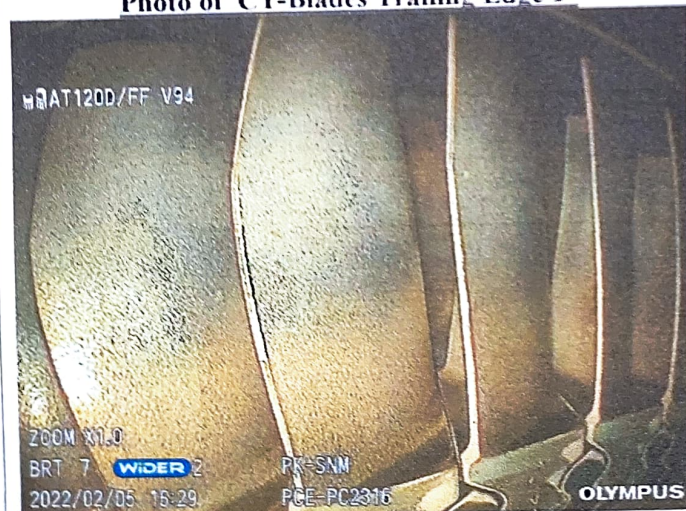
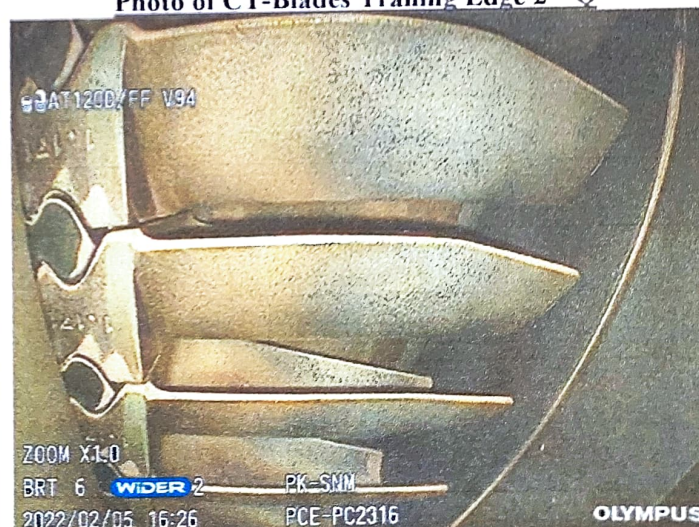
Perform inspection CT-Blades Trailing Edge

**RESULT SMALL TIP RUBBING ON SHROUD SEGMENTS**

**PT6A-114A EMM 72-50-02 Figure 204 (Acceptable Conditions, Repair Unnecessary)**

Photo of CT-Blades Trailing Edge 1<sup>st</sup>

Photo of CT-Blades Trailing Edge 2<sup>nd</sup> Q

Photo of CT-Blades Trailing Edge 3<sup>rd</sup> Q

Photo of CT-Blades Trailing Edge 4<sup>th</sup> Q

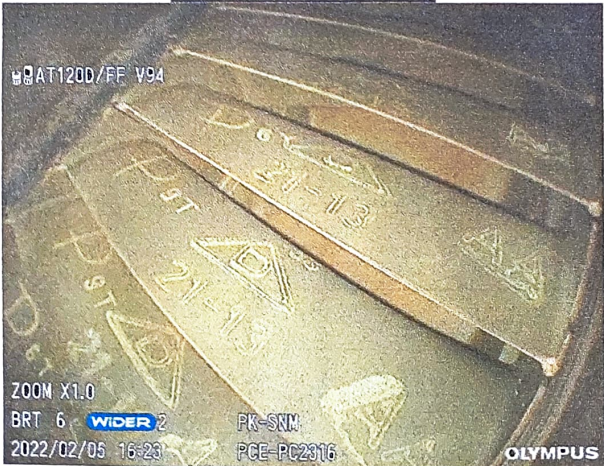
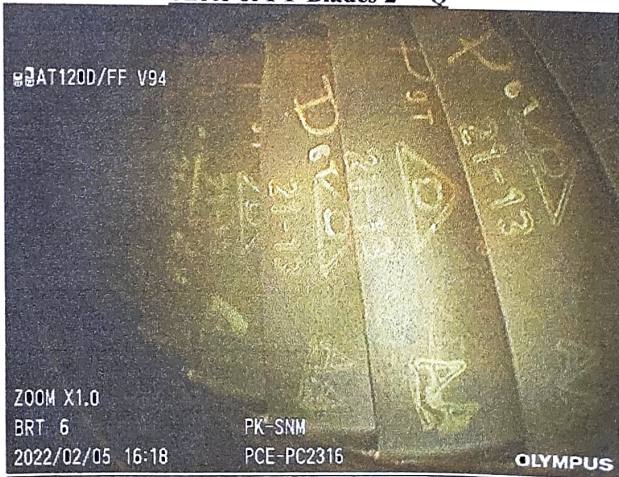
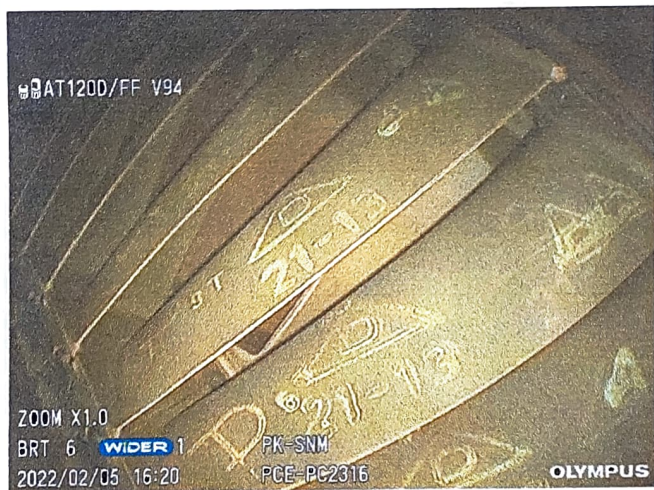
Perform inspection of PT-Blades  
Defects:

**RESULT FOUND NO DEFECT**

Photo of PT-Blades 1<sup>st</sup> Q

Photo of PT-Blades 2<sup>nd</sup> Q

**Photo of PT-Blades 3<sup>rd</sup> Q**

**Photo of PT-Blades 4<sup>th</sup> Q**
