**Engine Borescope Inspection**

**Job No: WO/044-SNH/VI/2023**

<u>Engine Serial Number</u>	<u>Date</u>	<u>Base / Location</u>	<u>Aircraft Registration</u>
PCE-VA0662	09 JUNE 2023	NABIRE	PK-SNH
<u>Aircraft Total Time</u>	<u>Aircraft Total Cycle</u>	<u>Reason For Borescope</u>	
3599:42 Hours	5372 Cycle	<b>400 HOURS INSPECTION</b>

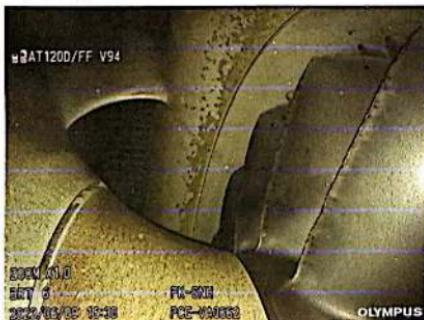
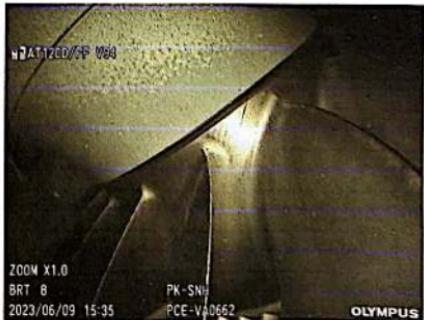
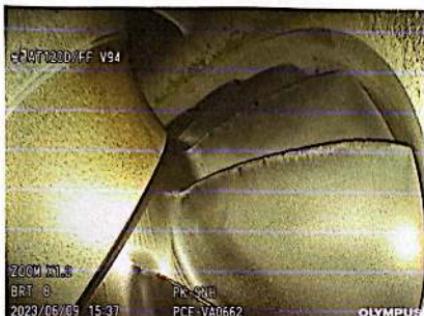
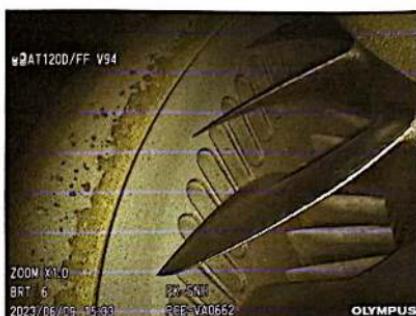
<u>Item</u>	<u>Work Description</u>	<u>SIGN</u>	<u>STAMP</u>
1	Remove fuel manifold adapter as necessary (Ref. 73-10-04).	(LJ)	27
2	Perform inspection of the First Stage Compressor. Defects: <b>RESULT FOUND NO DEFECT</b>  <u>If defects found, quote MM Limitation and References:</u>	(LJ)	27

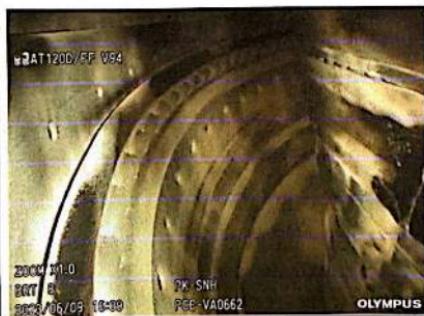
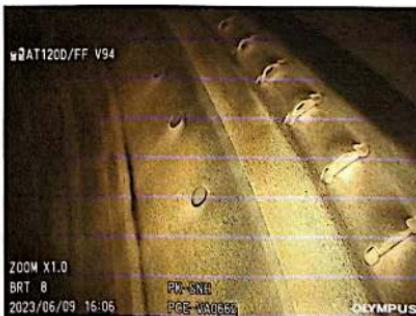
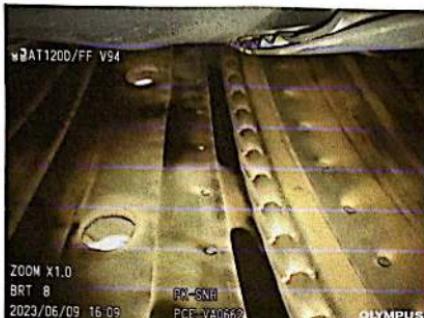
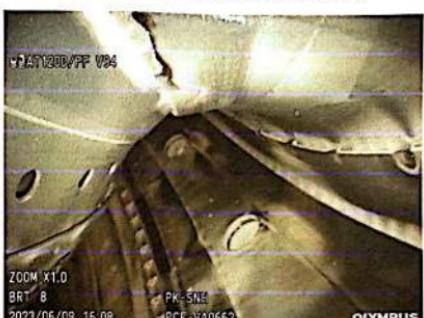
**LOCALIZED BURNING AND CARBON BUILD UP OF THE  
COOLING RING**

PT6A-140 EMM 72-00-00-280-804 (Acceptable Conditions)

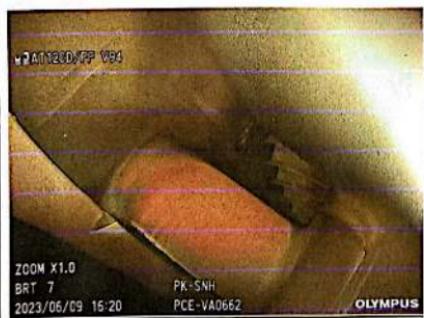
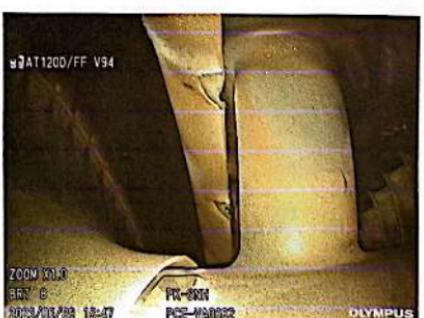
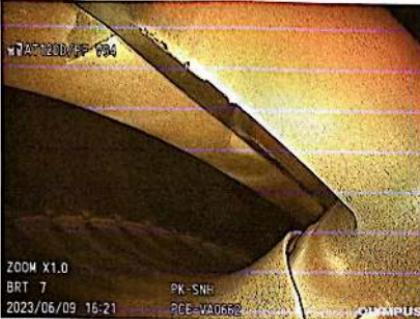
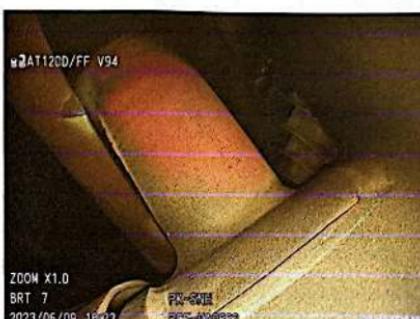
**RESULT FOUND COATING LOSS AND BURNING OF PARENT MATERIAL ON SMALL EXIT DUCT-SERVICEABLE CRITERIA – CONTINUE IN SERVICE**

If defects found, quote MM Limitation and References:  
PT6A-140 EMM 72-00-00-280-804 TABLE 602 AREA 2&  
TASK 72-40-01-210-804 FIGURE 207 SHEET 2 OF 2

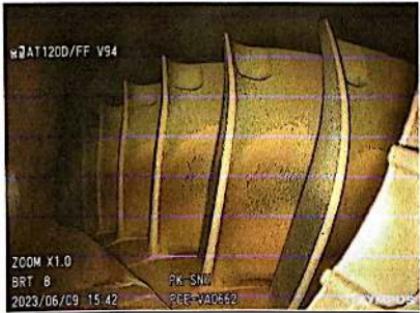
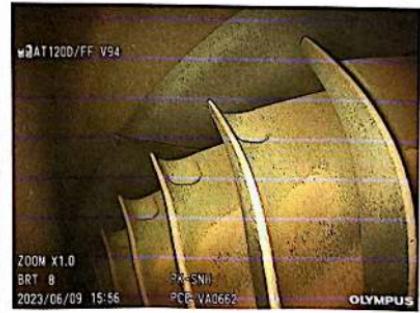
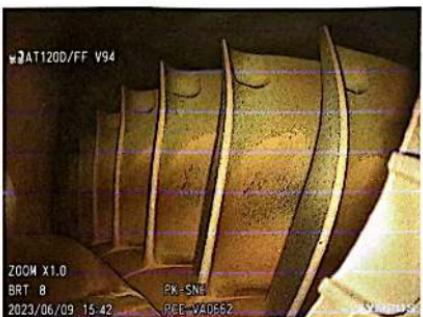
<p>ZOOM X1.0 BRT 7 2023/06/09 16:23</p> <p>PK-SNH PCE-VA0652</p> <p>OLYMPUS</p>	
<p><b>5</b> Perform inspection of CT-Blades and shroud segments.  <u>Defects:</u>  <b>RESULT FOUND NO DEFECT</b></p> <p>If defects found, quote MM Limitation and References:</p>	<p><b>SIGN</b></p>

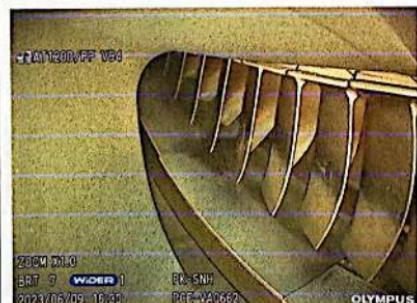
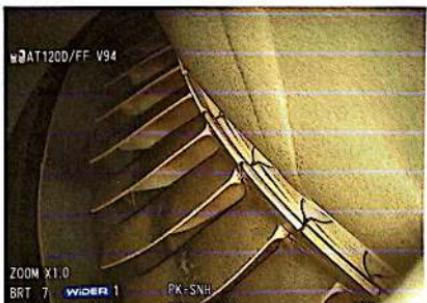
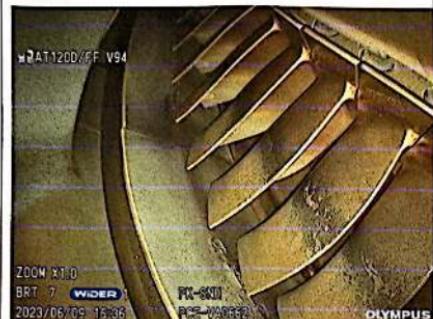
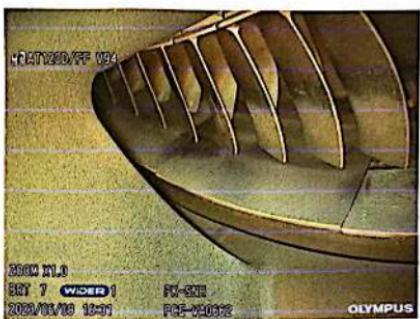
**RESULT FOUND SMALL RUBBING ON CT SHROUD SEGMENTS -  
SERVICEABLE CRITERIA - CONTINUE IN SERVICE**

If defects found, quote MM Limitation and References:  
PT6A-140 EMM 72-00-00-280-808 TABLE 605

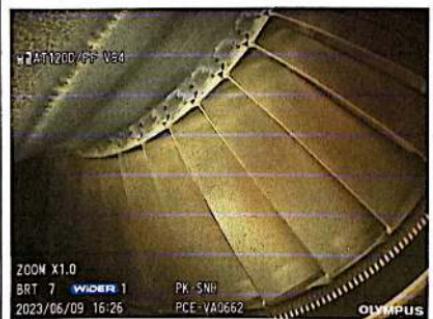
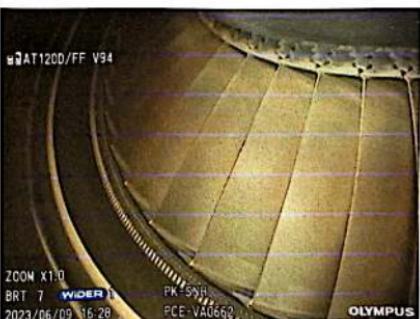
**RESULT FOUND NO DEFECT**
