PT. SMART CAKRAWALA AVIATION

## WORK ORDER

| Subject :<br><b>Inspection 400Hours &amp; Add.Task Insp.</b> | No. | WO/051-SNG/VI/2023 |
| | A/C Reg. | PK-SNG C208B-5543 |

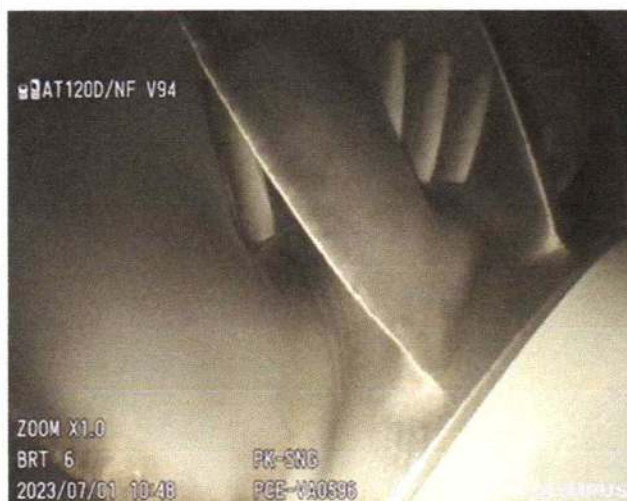
Photo of First Stage Compressor 1<sup>st</sup> Quadrant

| Item | Work Description | SIGN | STAMP |
|---|---|---|---|
| 2 | Perform inspection of the First Stage Compressor.<br>Defects:<br><b>RESULT SATISFACTORY FOUND NO DEFECT</b> | | |

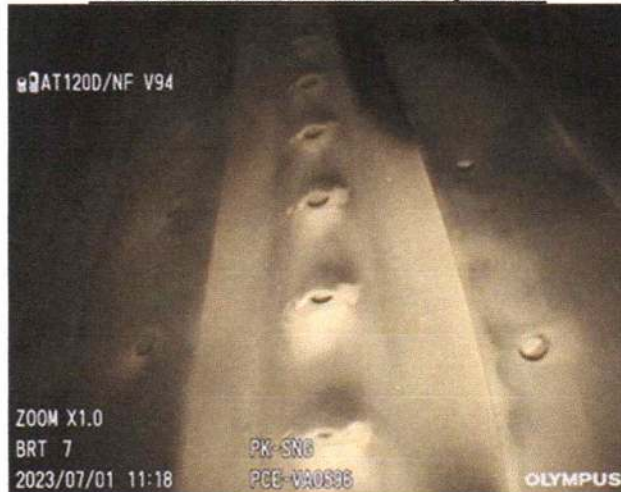
**Photo of Combustion Chamber 1<sup>st</sup> Quadrant**

Perform inspection of Combustion Chamber Liner Assembly.

**RESULT SATISFACTORY FOUND NO DEFECT**

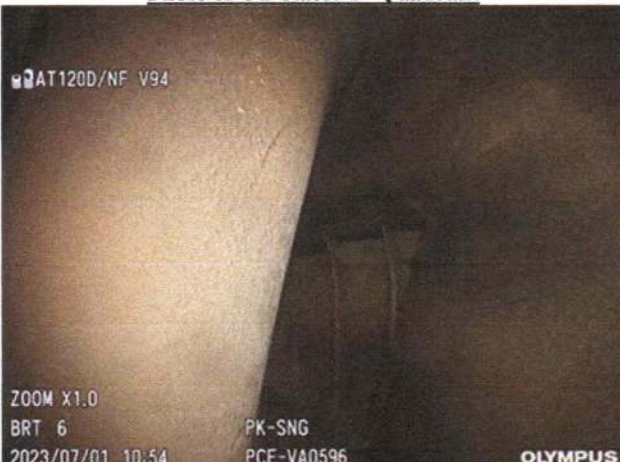
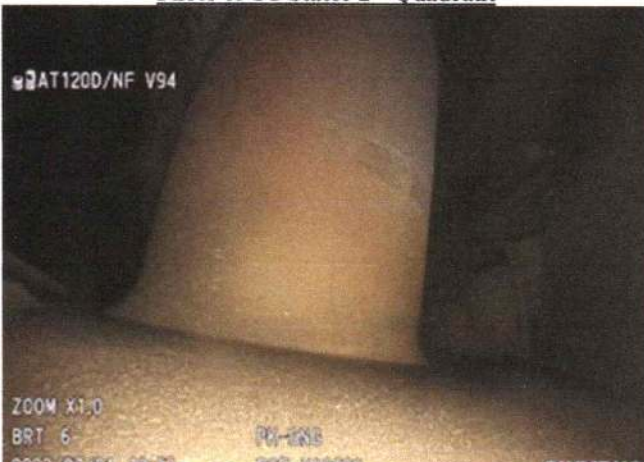
| 4 | Perform Inspection of CT-Stator assembly.<br><u>Defects:</u><br><b>RESULT SATISFACTORY FOUND NO DEFECT</b> | SIGN | STAMP |
| <b>Photo of CT Stator 1<sup>st</sup> Quadrant</b><br> <p>AT120D/NF V94<br/>ZOOM X1.0<br/>BRT 6<br/>2023/07/01 10:54<br/>PK-SNG<br/>PCE-VA0596<br/>OLYMPUS</p> | | <b>Photo of CT Stator 2<sup>nd</sup> Quadrant</b><br> <p>AT120D/NF V94<br/>ZOOM X1.0<br/>BRT 6<br/>2023/07/01 10:57<br/>PK-SNG<br/>PCE-VA0596<br/>OLYMPUS</p> | |

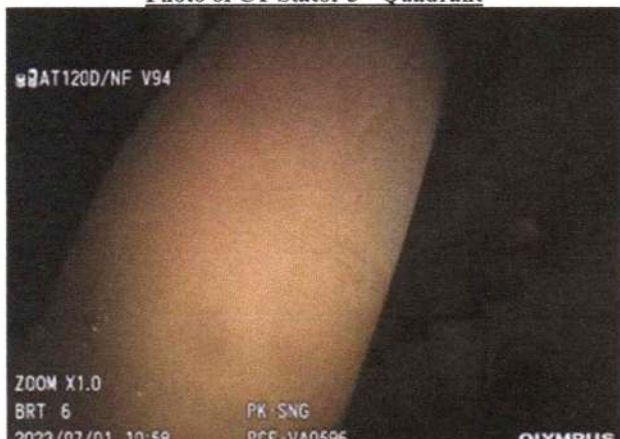
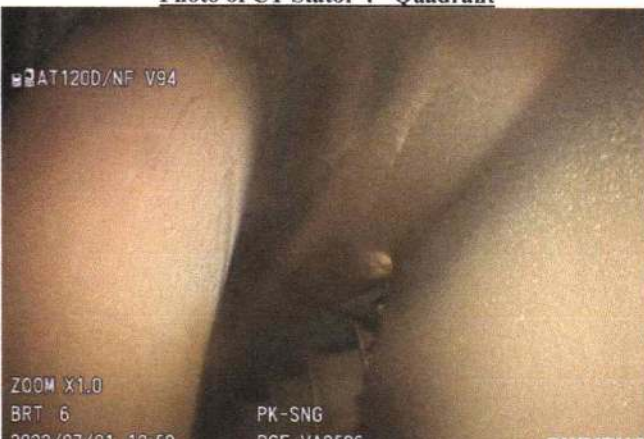
| <b>Photo of CT Stator 3<sup>rd</sup> Quadrant</b><br> <p>AT120D/NF V94<br/>ZOOM X1.0<br/>BRT 6<br/>2023/07/01 10:58<br/>PK-SNG<br/>PCE-VA0596<br/>OLYMPUS</p> | | <b>Photo of CT Stator 4<sup>th</sup> Quadrant</b><br> <p>AT120D/NF V94<br/>ZOOM X1.0<br/>BRT 6<br/>2023/07/01 10:59<br/>PK-SNG<br/>PCE-VA0596<br/>OLYMPUS</p> | |

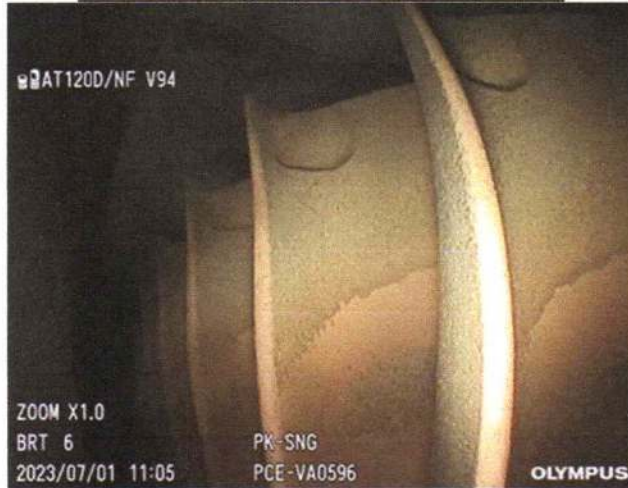
Photo of Leading Edge CT-Blades 1<sup>st</sup> Quadrant

| 5 | Perform inspection of CT-Blades and shroud segments.<br><u>Defects:</u><br><b>RESULT SATISFACTORY FOUND NO DEFECT</b> | SIGN | STAMP |

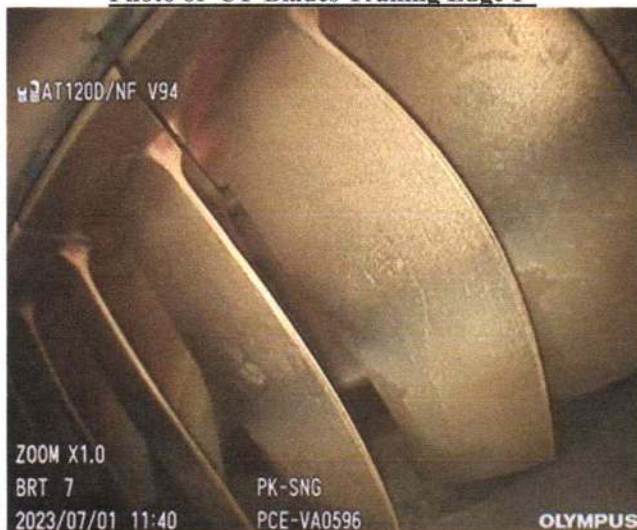
Photo of CT-Blades Trailing Edge 1<sup>st</sup>

Perform inspection CT-Blades Trailing Edge  
Defects:

**RESULT SATISFACTORY FOUND NO DEFECT**

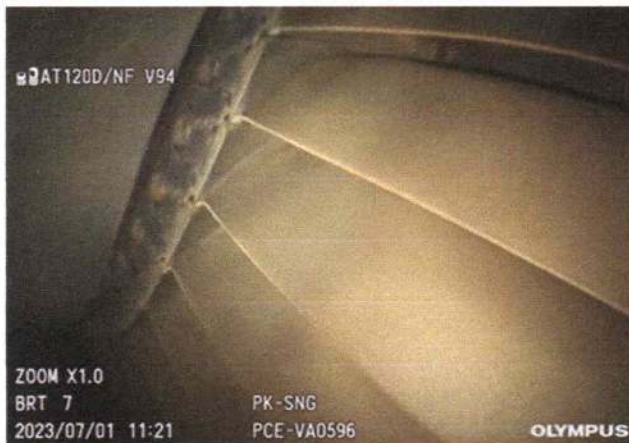
**Photo of PT-Blades 1<sup>st</sup> Q**

Perform inspection of PT-Blades

**RESULT SATISFACTORY FOUND NO DEFECT**
