PT. SMART CAKRAWALA AVIATION

Subject : Inspection 400 Hrs Engine & Add. Task	No.	WO/055-SNS/VI/2023
	Date	21 Jun 2023
	A/C Reg.	PK-SNS C208B-2341
Reference : MP C208B Issued 01	Prepared By	TS
	Checked By	CI
	Approved By	TM
To : Engineer In Charge		
Description : <ol style="list-style-type: none">1. Perform Inspection 400 Hours Engine&Add.Task2. Make an entry in Maintenance Log.3. Return the Completed Work Order and Form to PPC. <p>#If any finding, please close the routine card, and transferred to inspection card.</p>		
Additional Work : - NIL -		
Compliance Statement - CARRIED OUT -	Sign & Date Company Lic. No.: Rizki A. G 06 (Engineer In Charge)

Engine Borescope Inspection

Job No: **WO/055-SNS/VI/2023**

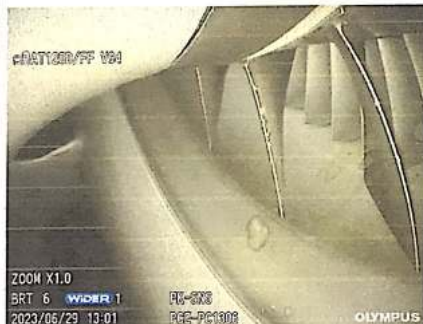
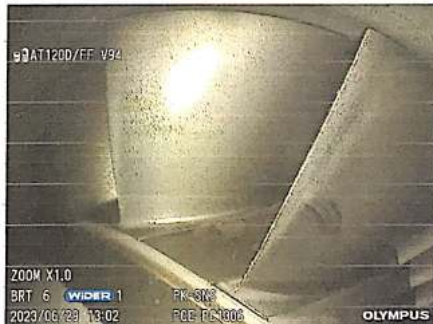
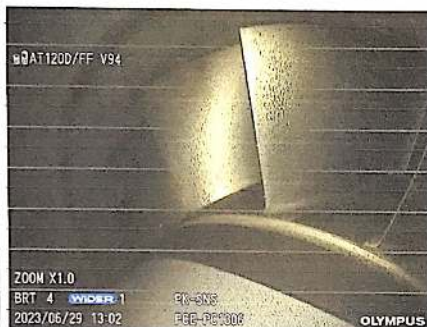
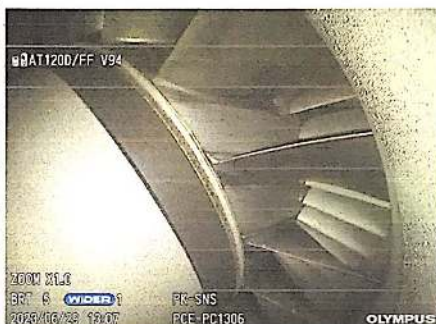
Item	Work Description	SIGN	STAMP
1	Remove fuel manifold adapter as necessary (Ref. 73-10-05).	<i>JA</i>	
2	Perform inspection of the First Stage Compressor. Defects: <u>RESULT FOUND NO DEFECT</u> <u>If defects found, quote MM Limitation and References :</u>	<i>JA</i>

Photo of First Stage Compressor 1st Quadrant

Photo of First Stage Compressor 2nd Quadrant

Photo of First Stage Compressor 3rd Quadrant

Photo of First Stage Compressor 4th Quadrant

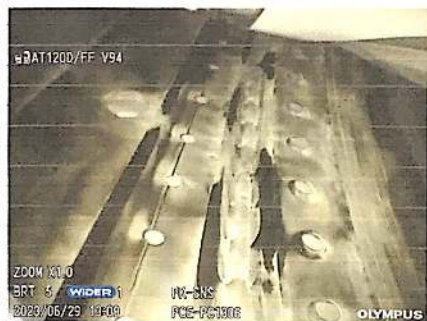
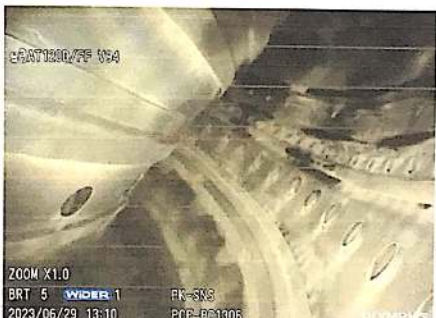
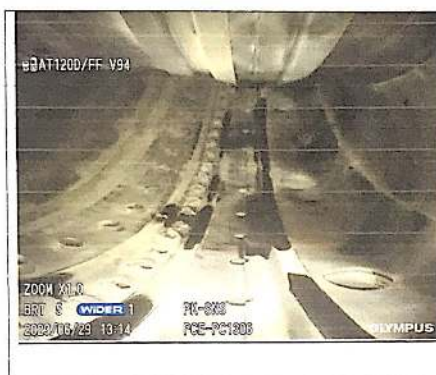
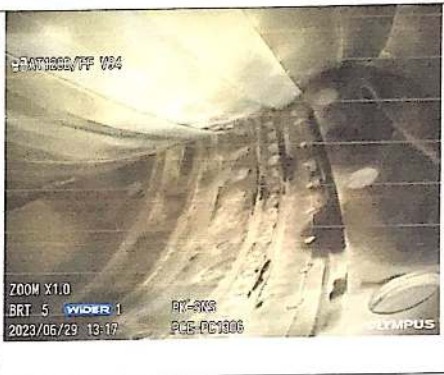
Perform inspection of Combustion Chamber Liner Assembly.

Carbon Build Up on some place around cooling hole

PT6A-114 EMM 72-40-01 Para. 6.B (Acceptable Condition, Repair and Unnecessary)

Photo of Combustion Chamber 1st Quadrant

Photo of Combustion Chamber 2nd Quadrant

Photo of Combustion Chamber 3rd Quadrant
Photo of Combustion Chamber 4th Quadrant

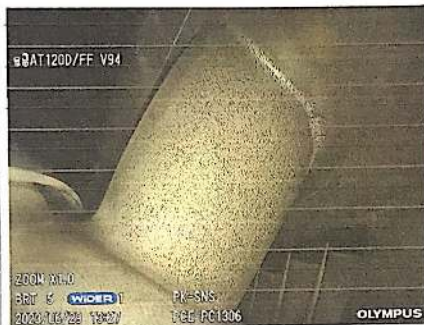
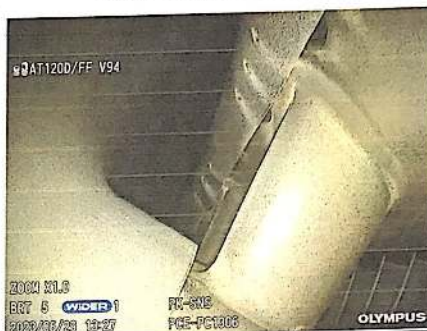
4	Perform Inspection of CT-Stator assembly.	SIGN	STAMP
	<p><u>Defects:</u> <u>RESULT FOUND NO DEFFECT</u></p> <p><u>If defects found, quote MM Limitation and References :</u></p>

Photo of CT Stator 3rd Quadrant

Photo of CT Stator 4th Quadrant

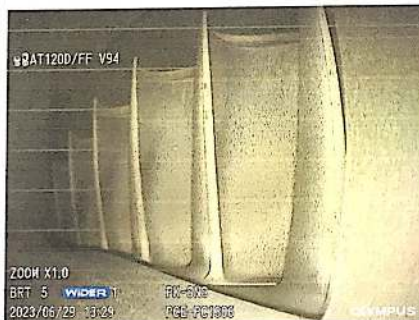
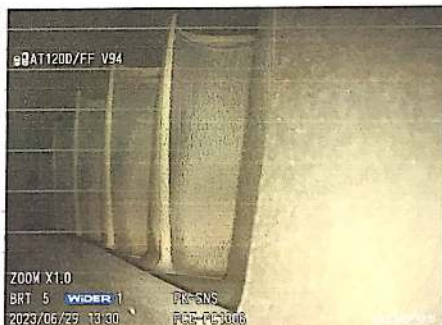
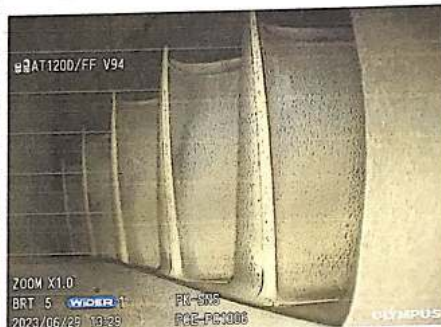
Perform inspection of CT-Blades and shroud segments.	SIGN	STAMP
5	<u>Defects:</u> RESULT FOUND NO DEFECT <u>If defects found, quote MM Limitation and References :</u>

Photo of Leading Edge CT-Blades 1st Quadrant

Photo of Leading Edge CT-Blades 2nd Quadrant

Photo of Leading Edge CT-Blades 3rd Quadrant

Photo of Leading Edge CT- Blade 4th Quadrant

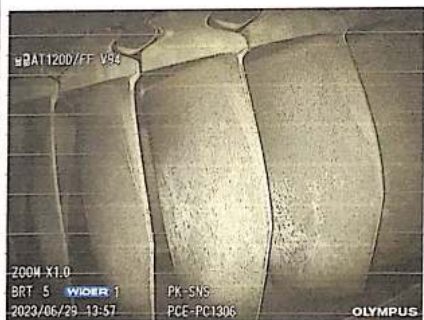
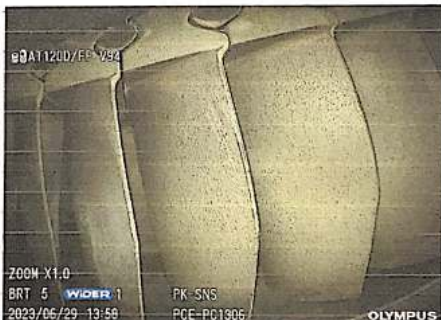
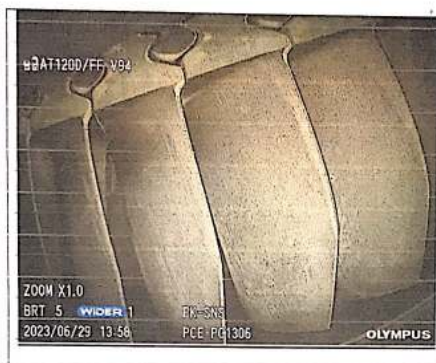
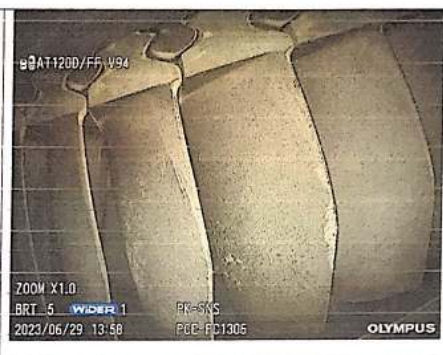
Perform inspection CT-Blades Trailing Edge

RESULT FOUND NO DEFECT

Photo of CT-Blades Trailing Edge 1st

Photo of CT-Blades Trailing Edge 2nd Q

Photo of CT-Blades Trailing Edge 3rd Q
Photo of CT-Blades Trailing Edge 4th Q

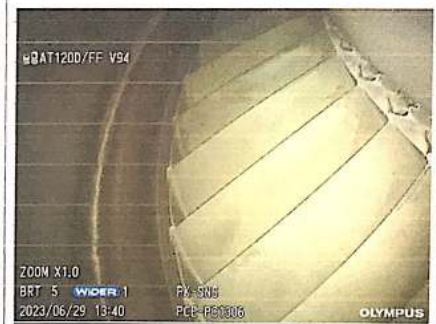
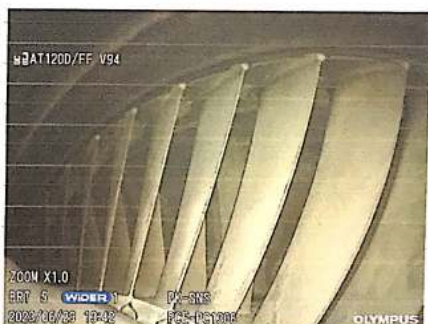
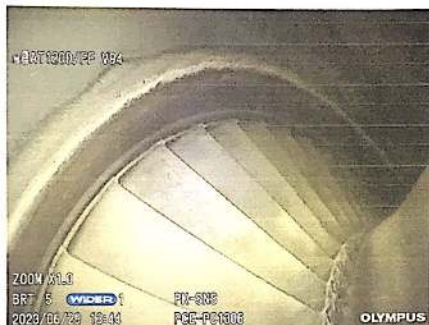
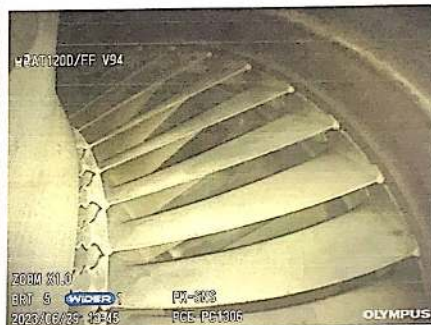
7	Perform inspection of PT-Blades <u>Defects:</u> RESULT FOUND NO DEFECT <u>If defects found, quote MM Limitation and References :</u>	SIGN

Photo of PT-Blades 1st Q

Photo of PT-Blades 2nd Q

Photo of PT-Blades 3rd Q

Photo of PT-Blades 4th Q
