PT. SMART CAKRAWALA AVIATION

| Subject :<br><b>200 Hours &amp; Add. Task Inspection</b> | No. | WO/070-SNS/X/2023 |

100HRS BORESCOPE INSPECTION AFTER DEFECT FOUND ON PK-SNS  
ENGINE PT6A-114A

Engine Borescope Inspection

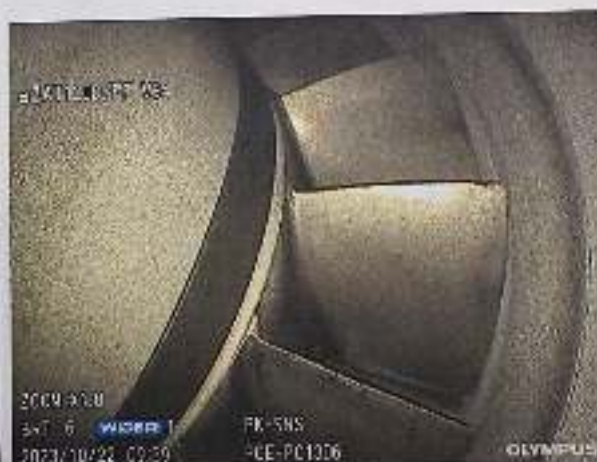
Photo of First Stage Compressor 1<sup>st</sup> Quadrant

| Item | Work Description | SIGN | STAMP |
|---|---|---|---|
| 2 | Perform inspection of the First Stage Compressor.<br>Defects:<br><b>RESULT SATISFACTORY FOUND NO DEFECT</b><br><u>If defects found, quote MM Limitation and References :</u> | | |

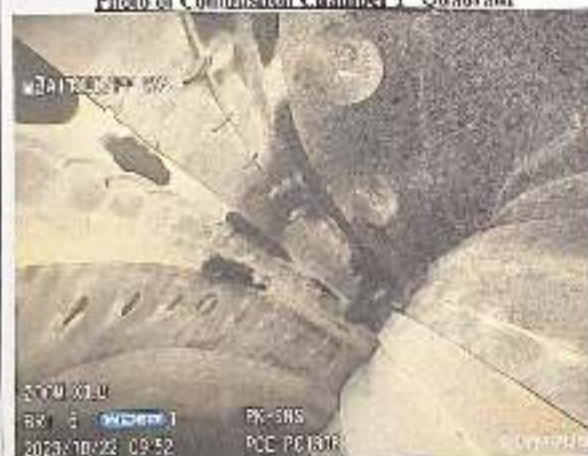
Photo of Combustion Chamber 1<sup>st</sup> Quadrant

Perform inspection of Combustion Chamber Liner Assembly.  
Defects:  
**Localized burning and carbon build up of the cooling ring**

If defects found, quote MM Limitation and References :  
**PT6A-114 EMM 72-40-01 Para. 6.8 (Acceptable Conditions, Repair Unnecessary)**

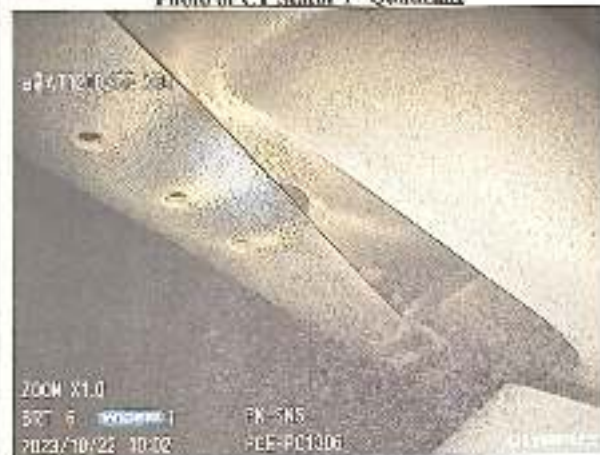
Photo of CT Stator 1<sup>st</sup> Quadrant

**RESULT FOUND INITIAL COATING DETERIORATION  
(SULFIDATION)**

If defects found, quote MM Limitation and References :  
**PT6A-114 EMM 72-50-01 Para. 6.A (Acceptable Conditions)**

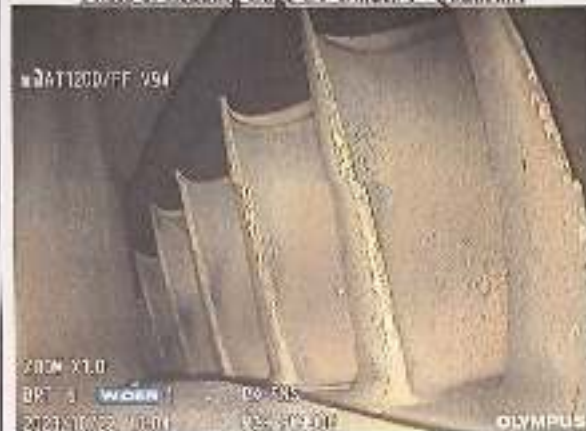
Photo of Leading Edge CT-Blades 1<sup>st</sup> Quadrant

**RESULT FOUND INITIAL COATING DETERIORATION  
(SULFIDATION)**

If defects found, quote MM Limitation and References :  
**PT6A-114 EMM 72-50-02 Para. 6.B (Acceptable Conditions)**

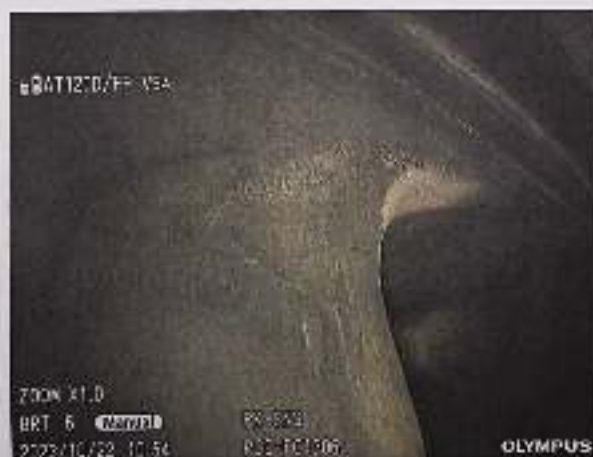
**Photo of PT-Blades 1<sup>st</sup> Q**

**FOUND FOUR SMALL CRACK ON THREE TRAILING EDGES  
VANE RING**

If defects found, quote MM Limitation and References :  
**PT6A-114 EMM 72-50-03 Para. 6.B**

Do the borescope inspection on 100 Hrs interval after finding defect on Power Turbine Stator section that is installed in PK-SNS with ESN PCE-PC1306. The inspection is for examining the defect found that exists on second sequence of borescope inspection (400 Hrs Interval) by 800 Hours engine total time.

Focus of the inspection in power turbine area to identify the crack must be not expanded and/or extended. The inspection should be strictly also performed to ensure there is no metal or particle debris found on engine related area.

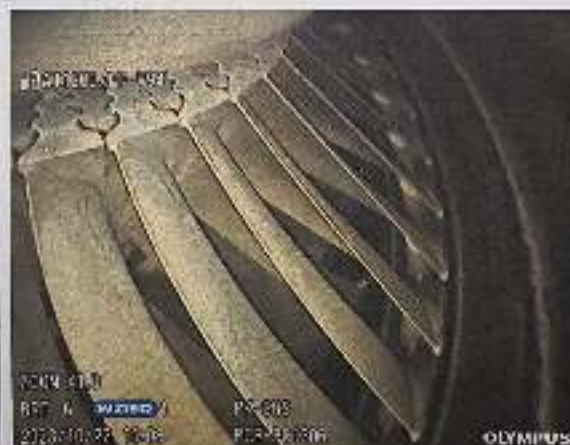
**Photo of PT-Blades 1<sup>st</sup> Q**

**RESULT SATISFACTORY FOUND NO DEFECT**
