PT. SMART CAKRAWALA AVIATION

WORK ORDER

Subject : **Inspection 10FH, 25FH, & EI-011**	No.	WO/103-PK-SNX/X/2023
	Date	25-OCT-2023
	A/C Reg.	PK-SNX EC130T2-8829
Reference : MP EC 130 T2 Rev. 2	Prepared By	TS
	Checked By	CI
	Approved By	TM

VISUAL INSPECTION OF THE REAR TRANSMISSION BEARING SUPPORT ASB EC130-05A039

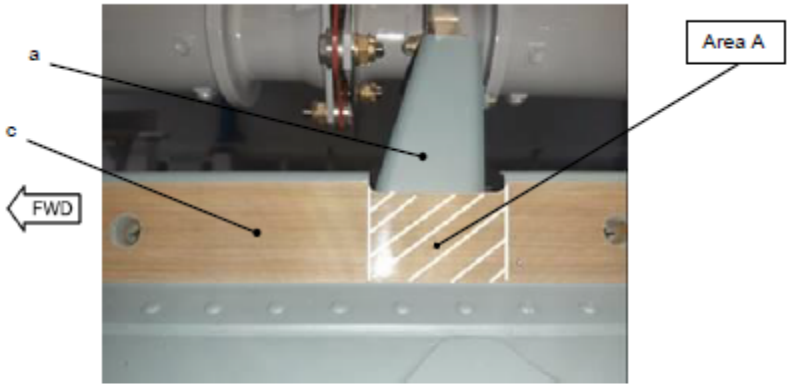
Figure 1

3.B.2.c. Removal of the Teflon tape from the tailboom (Figure 1)

- Unstick the Teflon tape (c) on the hatched area (A).
- Slip a protection (3) (not shown) between the Teflon tape (c) and the tailboom structure.

- Cut and remove the Teflon tape (c) on the hatched area (A) with the cutter (yy) (not shown).

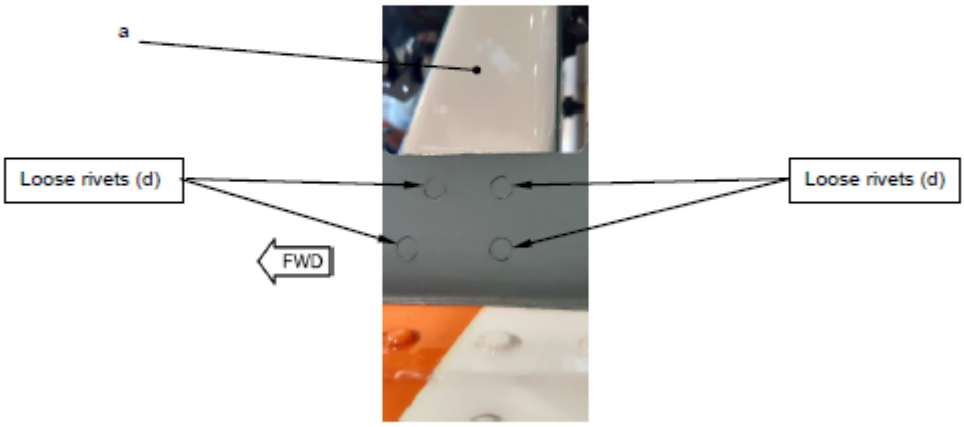
Figure 2

3.B.2.d. Visual inspection of the rivets head of the rear bearing support under the Teflon tape (Figure 2)

- Make sure that there is no missing, loose or sheared rivet (d) on the rear transmission bearing support (a) with the light source (zz).

A loose rivet is a rivet with black mark or missing paint around the rivet head, refer to the Figure 2.

- Comply with paragraph 3.B.2.e.
