DOCUMENT FORM BORESCOPE INSPECTION FORM

Engine Borescope Inspection

Job No: WO/089-SNK/X/2022

<u>Engine Serial Number</u> PCE-PC2316	<u>Date</u> 16-OCT-22	<u>Base / Location</u> TRK	<u>Aircraft Registration</u> PK-SNM
<u>Aircraft Total Time</u> 3865:18	<u>Aircraft Total Cycle</u> 5341	<u>Reason For Borescope</u> ON CONDITION

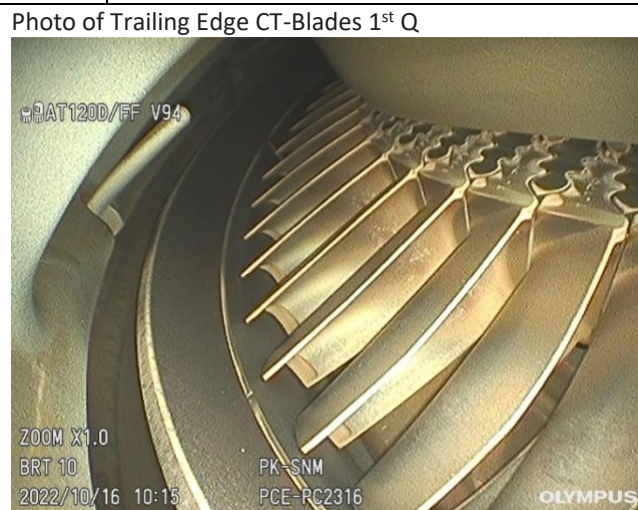
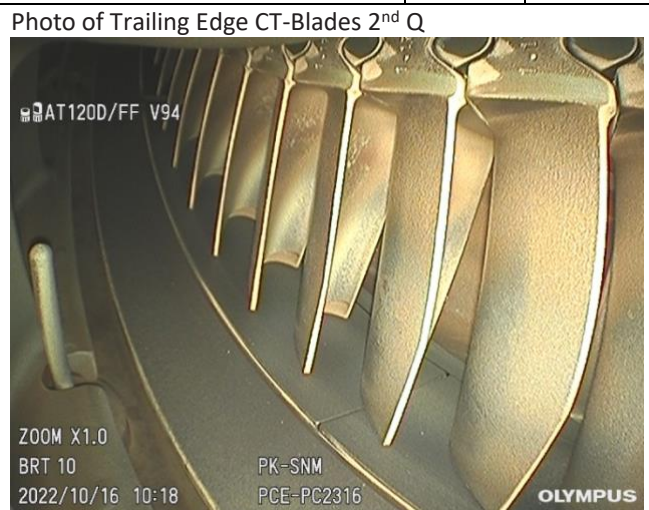
6	Perform inspection trailing edge of CT blades. <u>Defects:</u> RESULT FOUND SATISFACTORY <u>If defects found, quote MM Limitation and References :</u>	SIGN	STAMP
