MAINTENANCE PROGRAM

CESSNA 208/208B

DOCUMENT NUMBER	REVISION NUMBER	DATE
SCA/TEK/1-001	Issued: 01, Rev. 01	11 September 2023
PT. Smart Cakrawala Aviation

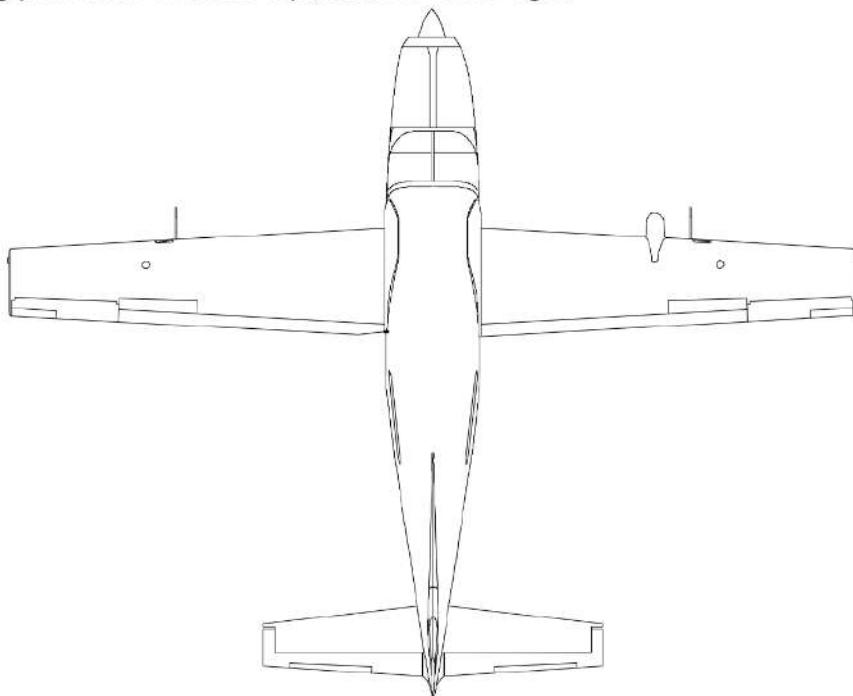
A. List any sweeping points, such as burn marks, divots, etc., and skin penetrations on airplane skin believed to be the result of the lightning strike. Itemize and reference location(s) of damage on drawing provided. Indicate top, bottom, left or right.

B. Describe damage to structure and external components caused by previously mentioned damage points. In the case of skin penetration(s), indicate hole diameter(s). List all damage to radome and any other composite structure, such as fairings, control surfaces, etc. If lightning diverter strips are damaged, include lightning diverter strip location(s) on radome. For damage to composite structure, paint thickness must be included in description.

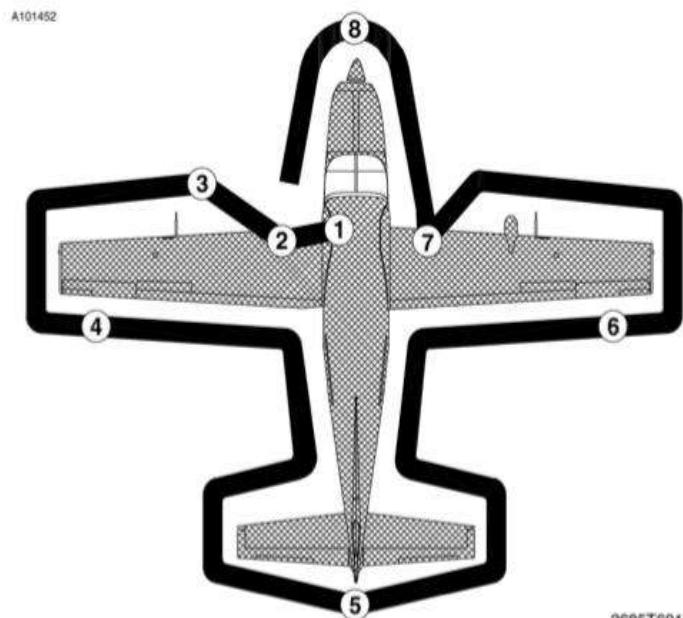
Visually check airplane for general condition during walk-around inspection.

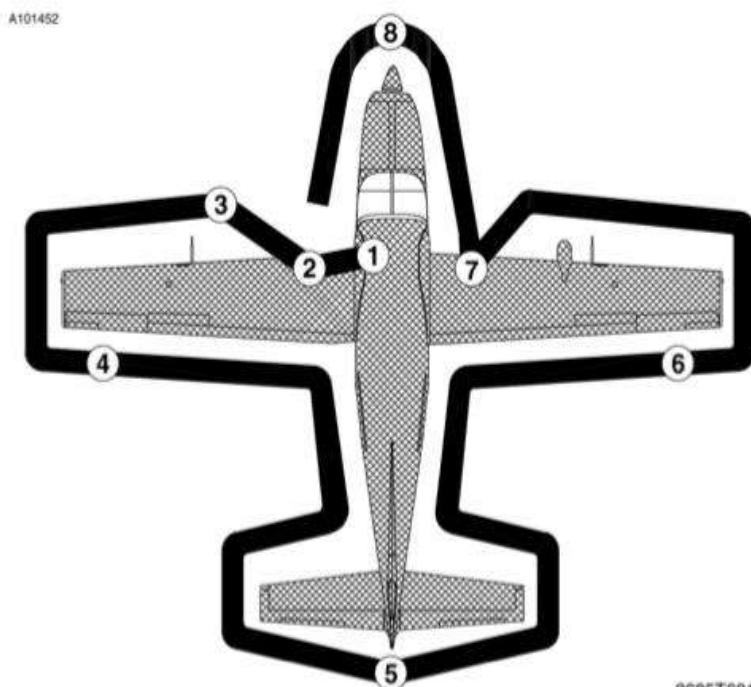
Visually check airplane for general condition during walk-around inspection.

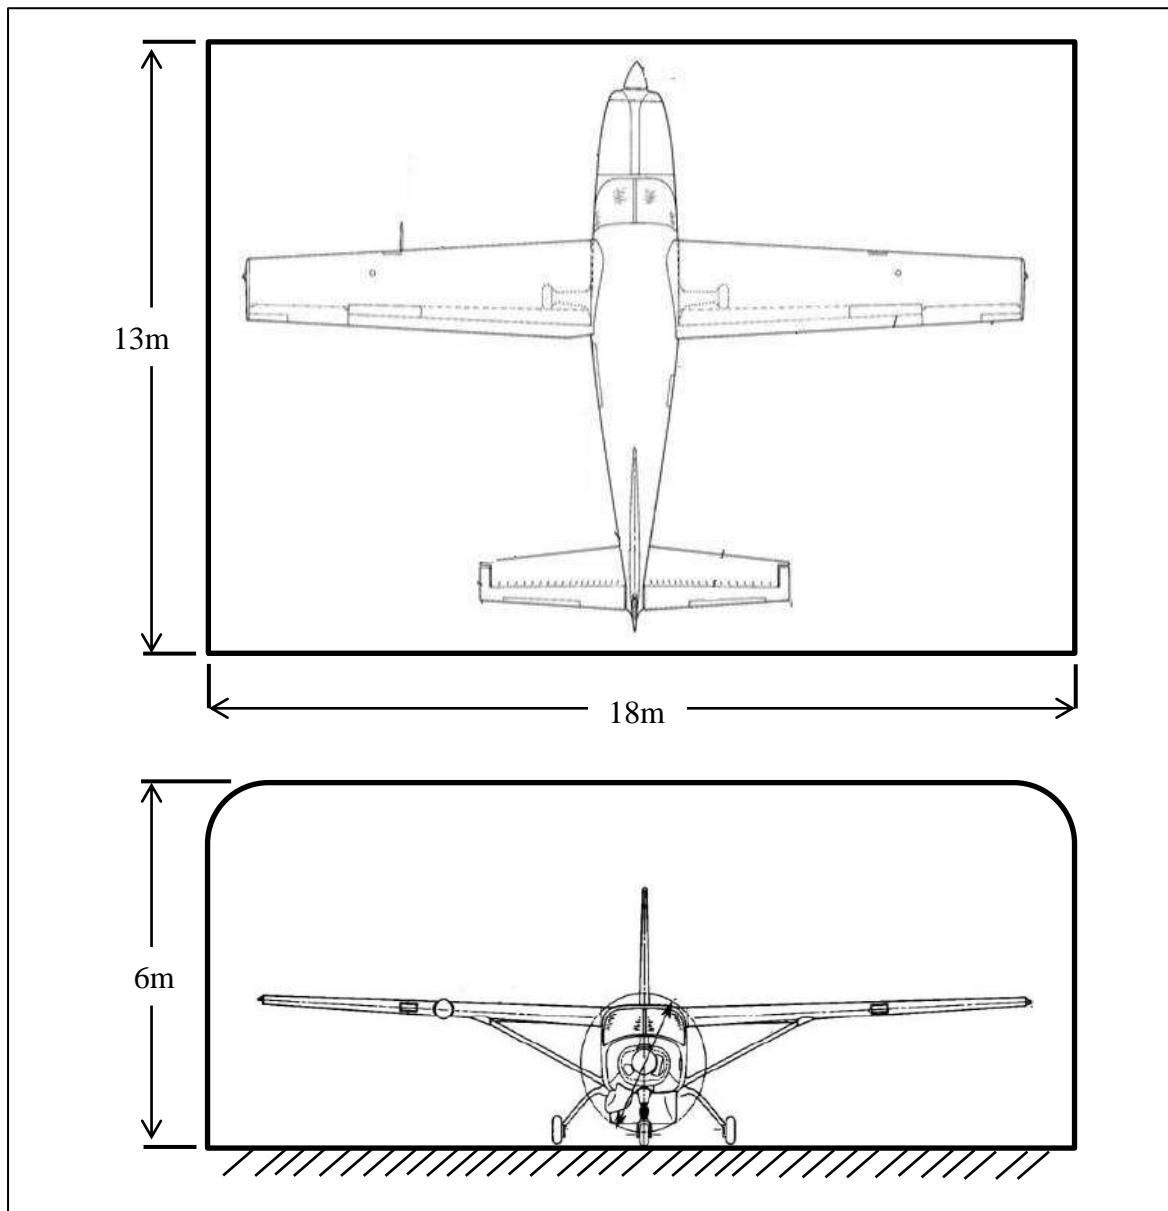
**Figure 1 – Size of Hangar Requirement**

- Size of Hangar have minimum requirement (See Figure 1)
 - 13m x 18m x 6m
- Power Source (220V)
- Lighting Support
- Air Pressure Source
- Maintenance Platforms / Stairs, height: 2 – 3 meters
- Security
- Fixed / portable crane, if required
- Cleanliness standardization
