PT. SMART CAKRAWALA AVIATION

Subject : Inspection Doc. 10 & Task Add Due at 800 FH.	No.	WO/017-SNA/I/2022
	Date	18-Jan-2022
	A/C Reg.	PK-SNA C208B-5634
Reference : MP C208B REV. 10	Prepared By	TS
	Checked By	CI
	Approved By	TM
To : Engineer In Charge		
<p>Description :</p> <ol style="list-style-type: none">1. Perform Inspection Doc. 10 & Task Add Due at 800 FH.2. Make an entry in Maintenance Log.3. Return the Completed Work Order and Form to PPC. <p>#If any finding, please close the routine card, and transferred to inspection card.</p>		
<p>Additional Work :</p> <p>REF TO FORM : SCA/MTC/01/ FOR MORE DETAIL</p>		
Compliance Statement CARRIED OUT	Sign & Date Company Lic. No.: (Engineer In Charge) 31 JAN 2022 DENI SORALI	Signature (Technical Manager)

CERTIFICATE RETURN TO SERVICE
SCHEDULED MAINTENANCE INSPECTION
(CRS-SMI)

A/C TYPE : CESSNA 208B TTSN : 791210
A/C REG : PK-SNA TCSN : 1185
MSN : C208B-5634 DATE : 31 JAN 2022

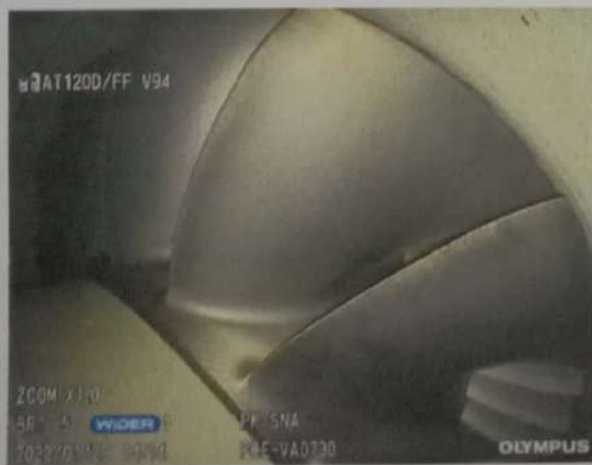
Photo of First Stage Compressor 1st Quadrant

Item	Work Description	SIGN	STAMP
1	Remove fuel manifold adapter as necessary (Ref. 73-10-04).		
2	Perform inspection of the First Stage Compressor. Defects: RESULT FOUND NO DEFECT <u>If defects found, quote MM Limitation and References:</u>

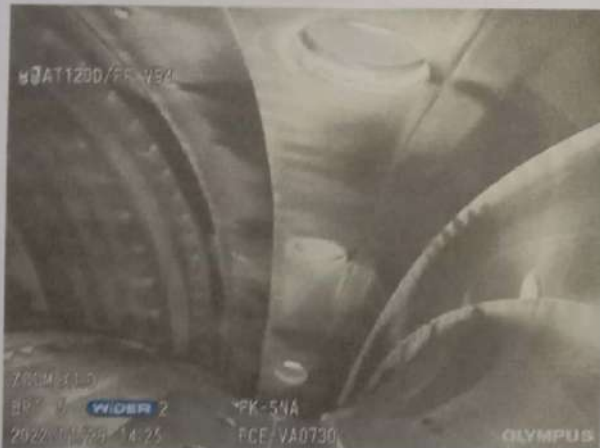
Photo of Combustion Chamber 1st Quadrant

Perform inspection of Combustion Chamber Liner Assembly. Defects:
Localized Burning and Carbon Build up of the Cooling Ring -
Serviceable Criteria - Continue in Service

If defects found, quote MM Limitation and References: **PT6A-140 EMM**
72-00-00-280-804 (Acceptable Conditions)

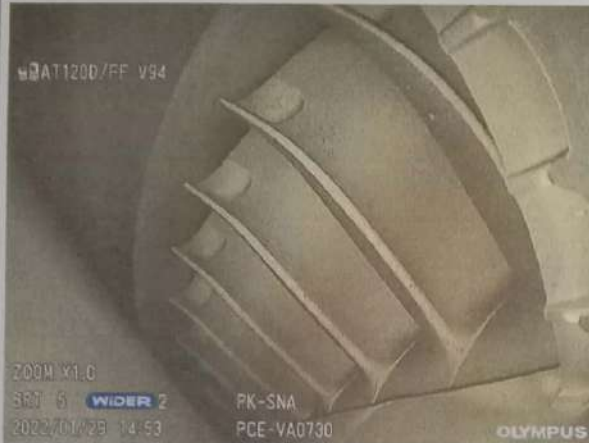
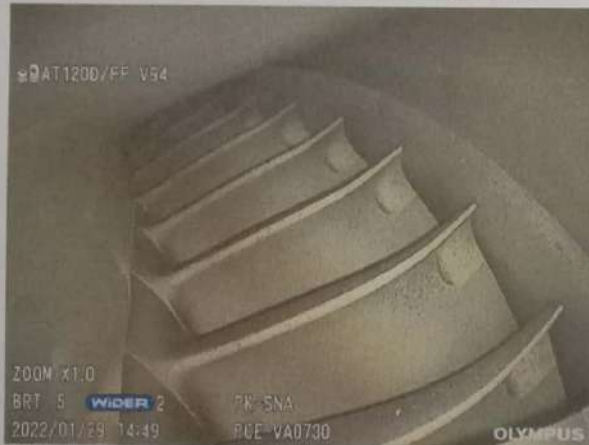
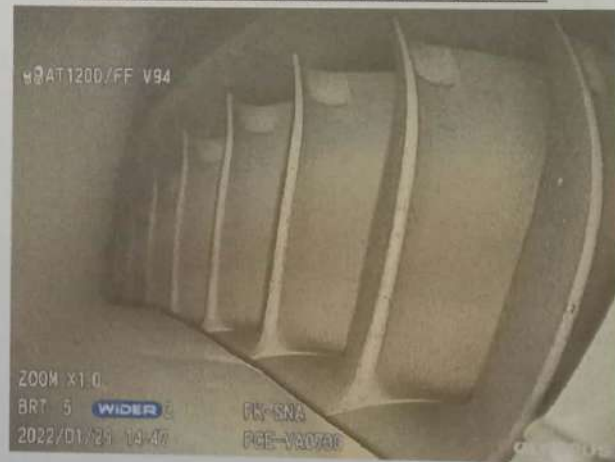
RESULT FOUND NO DEFECT

Photo of Leading Edge CT-Blades 1st Quadrant

Photo of Leading Edge CT-Blades 2nd Q

Photo of Leading Edge CT-Blades 3rd Quadrant

Photo of Leading Edge CT-Blades 4th Quadrant

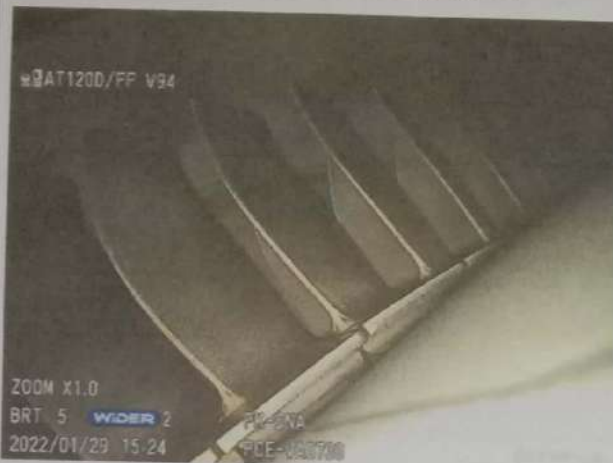
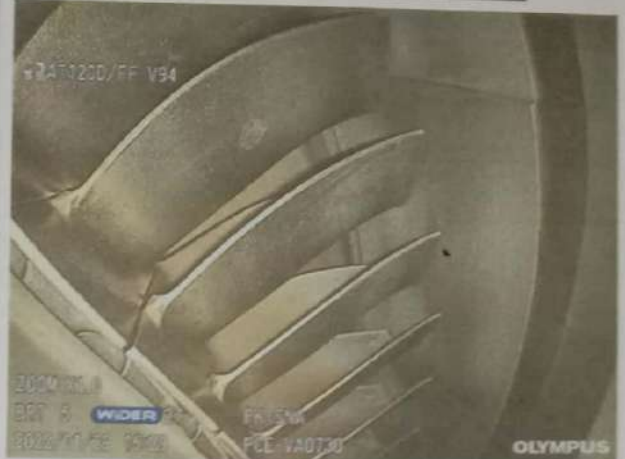
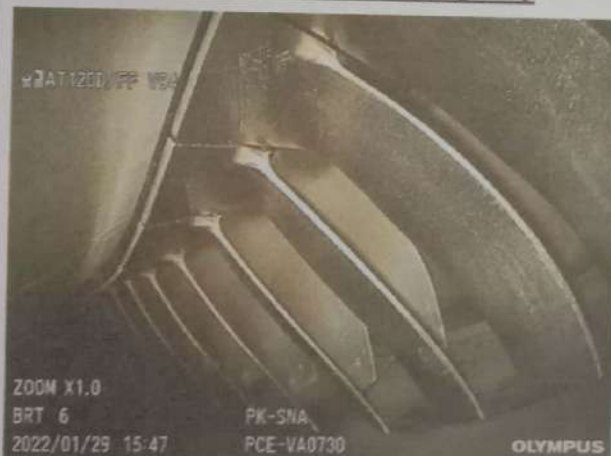
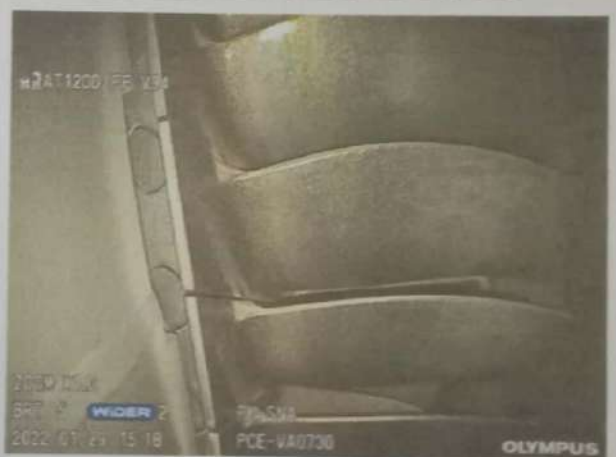
Perform inspection CT-Blades Trailing Edge Defects:
Result Found Rubbing on Shroud Segments Serviceable -
Criteria - Continue in Service

If defects found, quote MM Limitation and References:
PT6A-140 EMM 72-00-00-280-808 TABLE 605

Photo of CT-Blades Trailing Edge1st

Photo of CT-Blades Trailing Edge2nd Q

Photo of CT-Blades Trailing Edge3rd Q

Photo of CT-Blades Trailing Edge4th Q

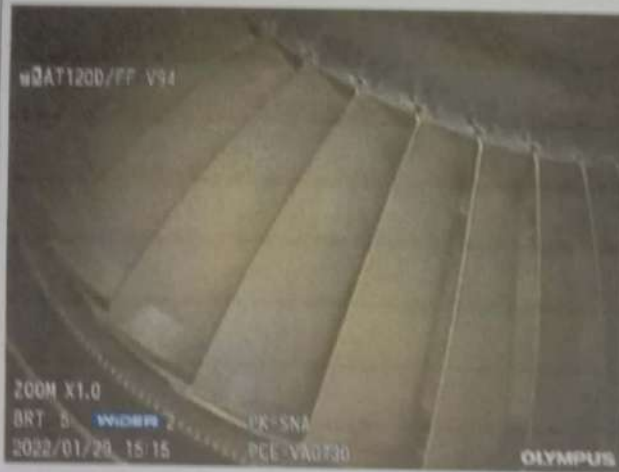
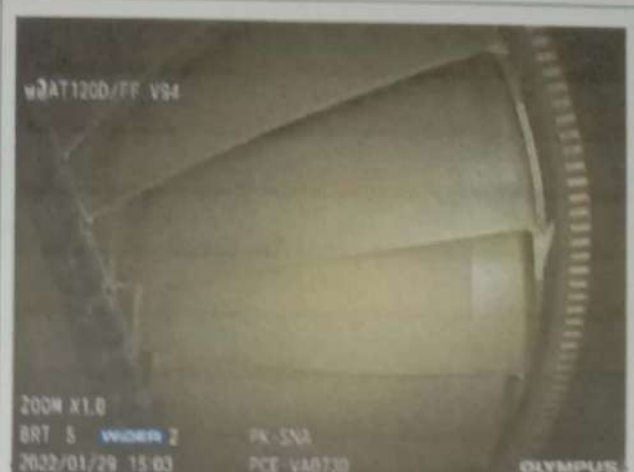
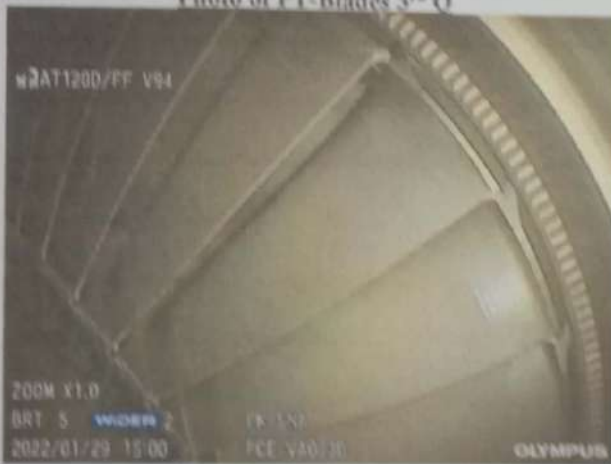
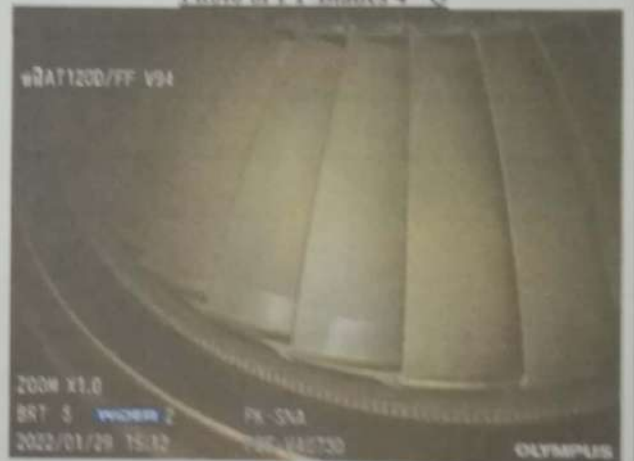
Perform inspection of PT-Blades
Defects:
RESULT FOUND NO DEFECT
If defects found, quote MM Limitation and References

Photo of PT-Blades 3rd O

Photo of PT-Blades 4th O
