PT. SMART CAKRAWALA AVIATION

| Subject :<br>Inspection 400 Hrs Eng.&Add.Eng.Task | No. | WO/041-SNP/IV/2023 |
| | A/C Reg. | PK-SNP C208B-5495 |

## Engine Borescope Inspection

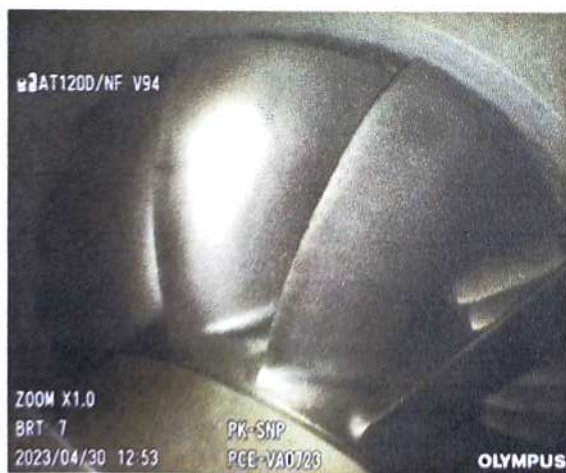
Photo of First Stage Compressor 1<sup>st</sup> Quadrant

| Item | Work Description | SIGN | STAMP |
|---|---|---|---|
| 2 | Perform inspection of the First Stage Compressor.<br>Defects:<br><b>RESULT SATISFACTORY FOUND NO DEFECT</b><br><br><u>If defects found, quote MM Limitation and References :</u> | | |

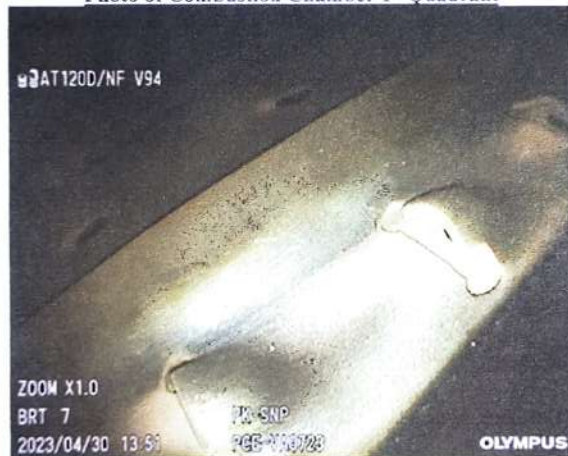
Photo of Combustion Chamber 1<sup>st</sup> Quadrant

Perform inspection of Combustion Chamber Liner Assembly.

**RESULT SATISFACTORY FOUND NO DEFECT**

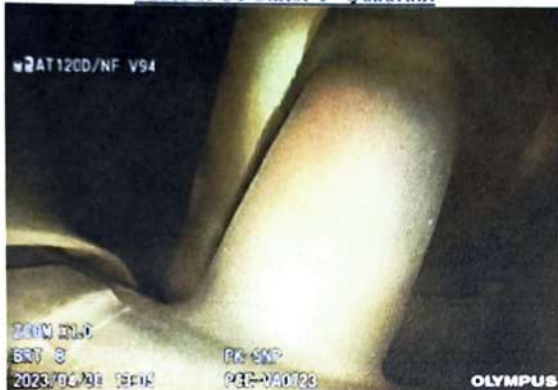
Photo of CT Stator 1<sup>st</sup> Quadrant

| 4 | Perform Inspection of CT-Stator assembly.<br><u>Defects:</u><br><b>RESULT SATISFACTORY FOUND NO DEFECT</b><br><br><u>If defects found, quote MM Limitation and References :</u> | SIGN | STAMP |

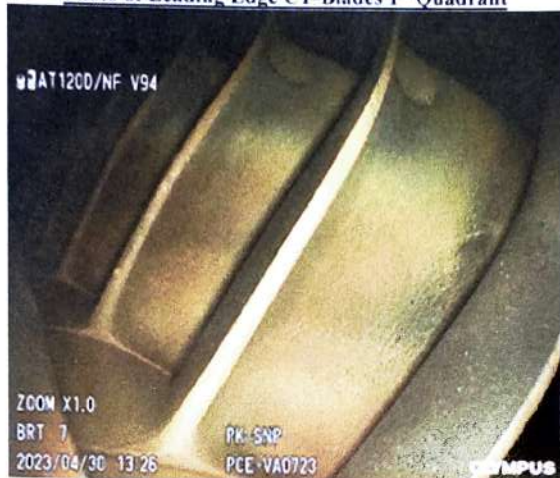
Photo of Leading Edge CT-Blades 1<sup>st</sup> Quadrant

| 5 | Perform inspection of CT-Blades and shroud segments.<br><u>Defects:</u><br><b>RESULT SATISFACTORY FOUND NO DEFECT</b><br><br><u>If defects found, quote MM Limitation and References :</u> | SIGN | STAMP |

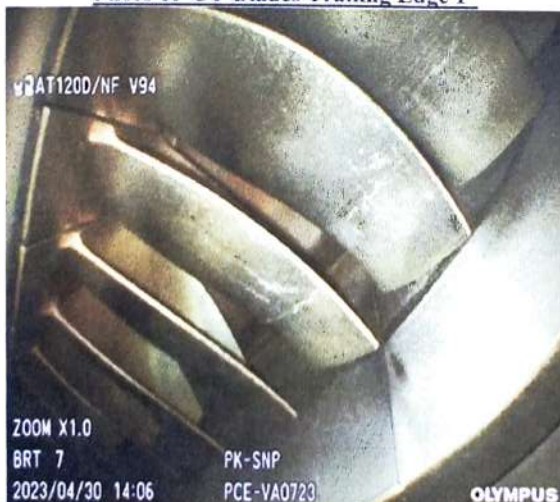
Photo of CT-Blades Trailing Edge 1<sup>st</sup>

Perform inspection CT-Blades Trailing Edge  
Defects:

**RESULT SATISFACTORY FOUND NO DEFECT**

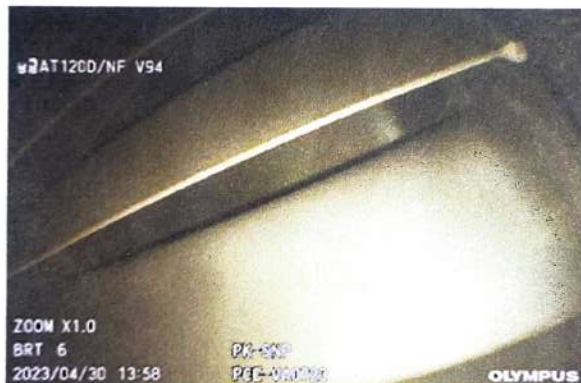
Photo of PT-Blades 1<sup>st</sup> Q

Perform inspection of PT-Blades

**RESULT SATISFACTORY FOUND NO DEFECT**
