PT. SMART CAKRAWALA AVIATION

## WORK ORDER

| Subject :<br>Inspection Document 08 & Add. Task | No. | WO/046-SNG/IX/2022 |
| | A/C Reg. | PK-SNG C208B-5543 |

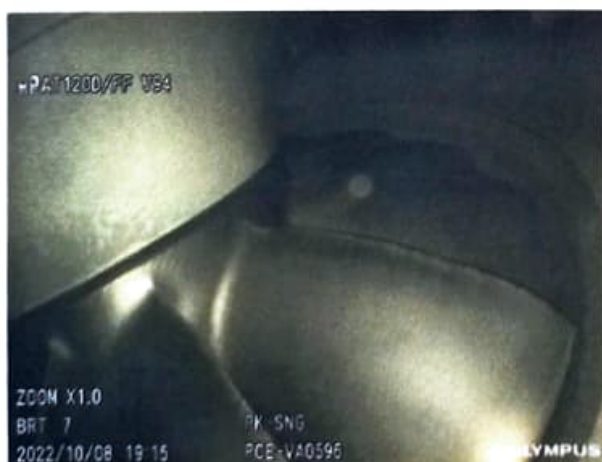
**Photo of First Stage Compressor 1<sup>st</sup> Quadrant**

| Item | Work Description | SIGN | STAMP |
|---|---|---|---|
| 2 | Perform inspection of the First Stage Compressor.<br>Defects:<br><b>RESULT SATISFACTORY FOUND NO DEFECT</b><br><br><u>If defects found, quote MM Limitation and References :</u> | | |

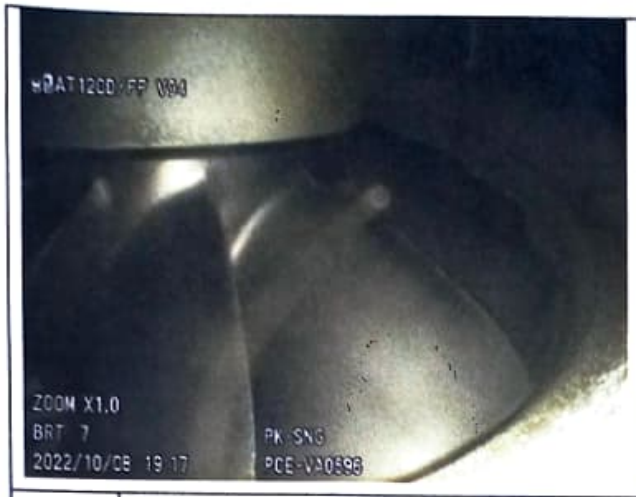
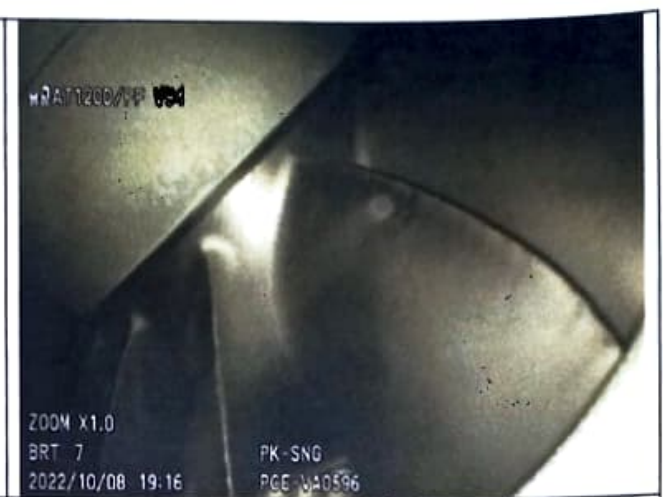
<p>WAT1200/FF V94</p> <p>ZOOM X1.0<br/>BRT 7<br/>2022/10/08 19:17</p> <p>PK-SNG<br/>PCE-VA0596</p>                                                                                                                                             |

<p>WAT1200/FF V94</p> <p>ZOOM X1.0<br/>BRT 7<br/>2022/10/08 19:16</p> <p>PK-SNG<br/>PCE-VA0596</p>                                                                                                                      |      |       |                                                                                     |                                                                                     |
|---|---|---|---|---|---|
| <p>3</p> <p>Perform inspection of Combustion Chamber Liner Assembly.</p> <p><b>Defects:</b><br/><b>Localized burning and carbon build up of the cooling ring</b></p> <p><b>If defects found, quote MM Limitation and References :</b><br/><b>PT6A-140 EMM 72-40-01 Para. 6.B (Acceptable Conditions, Repair Unnecessary)</b></p> | <table border="1"> <thead> <tr> <th>SIGN</th> <th>STAMP</th> </tr> </thead> <tbody> <tr> <td>

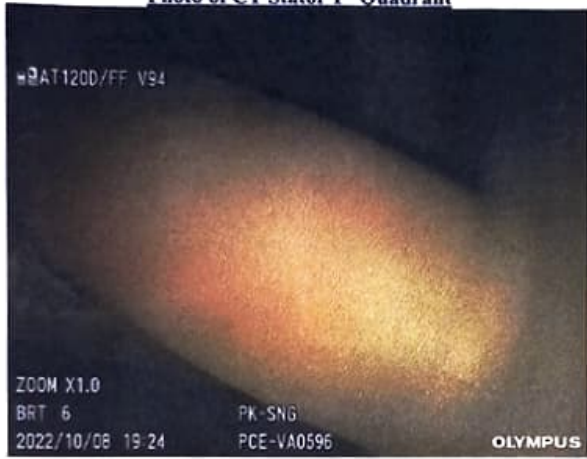
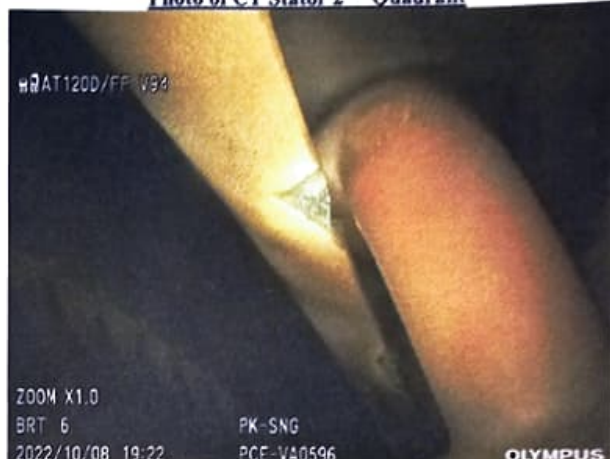
| 4 | Perform Inspection of CT-Stator assembly.<br><u>Defects:</u><br><br><b>Burning of parent material on small exit duct. Acceptable condition</b><br><br><u>If defects found, quote MM Limitation and References :</u><br><b>PT6A-140 EMM 72-50-01 Para. 6.C</b> | SIGN<br><br> | STAMP<br><br> |

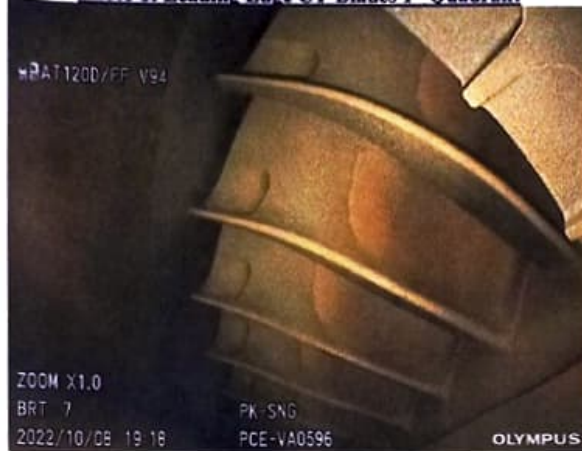
**Photo of Leading Edge CT-Blades 1<sup>st</sup> Quadrant**

| 5 | Perform inspection of CT-Blades and shroud segments.<br><u>Defects:</u><br><br><b>RESULT SATISFACTORY FOUND NO DEFECT</b><br><br><u>If defects found, quote MM Limitation and References :</u> | SIGN<br><br> | STAMP<br><br> |

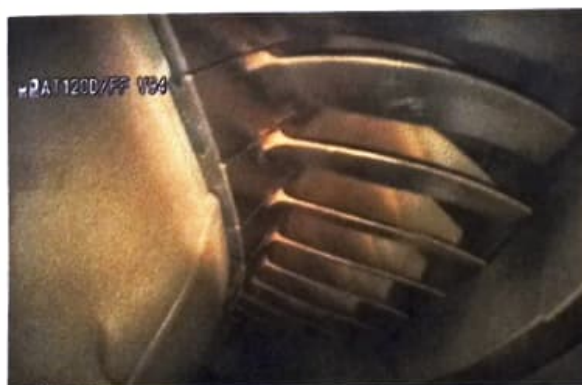
**Photo of CT-Blades Trailing Edge 1<sup>st</sup>**

**RESULT SATISFACTORY FOUND NO DEFECT**

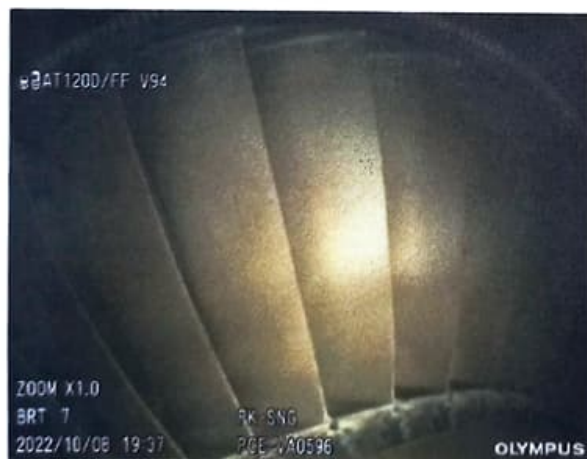
**Photo of PT-Blades 1<sup>st</sup> Q**

Defects:
**RESULT SATISFACTORY FOUND NO DEFECT**
If defects found, quote MM Limitation and References :
