## WORK ORDER

| Subject :<br>Inspection Document 10 & Add Task | No. | WO/108-SNM/XI/2022 |
| | A/C Reg. | PK-SNM C208-00655 |

# CERTIFICATE RETURN TO SERVICE

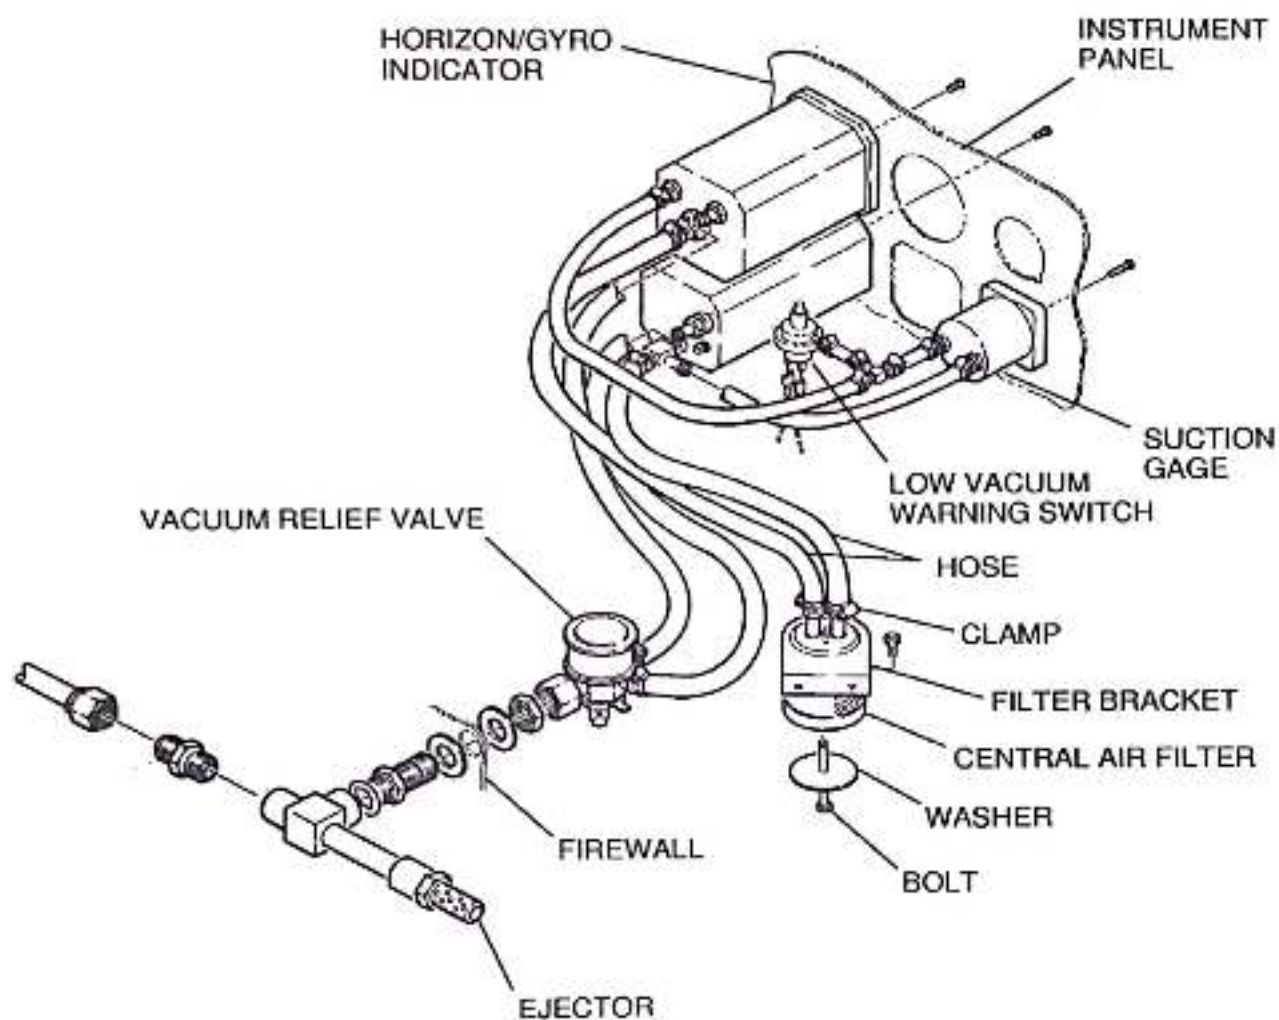
Figure 301 : Sheet 1 : Vacuum System Central Air Filter Servicing

- A. Remove Air Filter (Refer to Figure 301).

- (1) Unscrew bolt and washer from bottom of central air filter.
- (2) Remove central air filter from filter bracket.
- (3) Inspect for damage, deterioration and contamination. Clean or replace as required.

- B. Install Air Filter (Refer to Figure 301 ).

- (1) Seat central air filter up and into filter bracket.
- (2) Secure central air filter to filter bracket using bolt and washer.
- (3) Check central air filter for unobstructed flow. A properly functioning filter should allow a reading of at least 4.5 inches Hg (mercury) on the instrument panel suction gage.

PERFORMED VACUUM SYSTEM CENTRAL AIR  
FILTER REPLACEMENT. CHECK GOOD.

**D. Discard the Vacuum System Central Air Filter.**

(1) Remove the vacuum system central air filter. Refer to Chapter 12, Vacuum System Central Air Filter - Servicing.

(a) Discard the filter.

(2) Install a new vacuum system central air filter. Refer to Chapter 12, Vacuum System Central Air Filter - Servicing.
